COMPANY CONFIDENTIAL  
NLR-CR-2014-129

## Inventory of corrosion occurrences on two NH90 helicopters after operation in tropical and saline environment

L. 't Hoen-Velterop

Nationaal Lucht- en Ruimtevaartlaboratorium  
National Aerospace Laboratory NLR

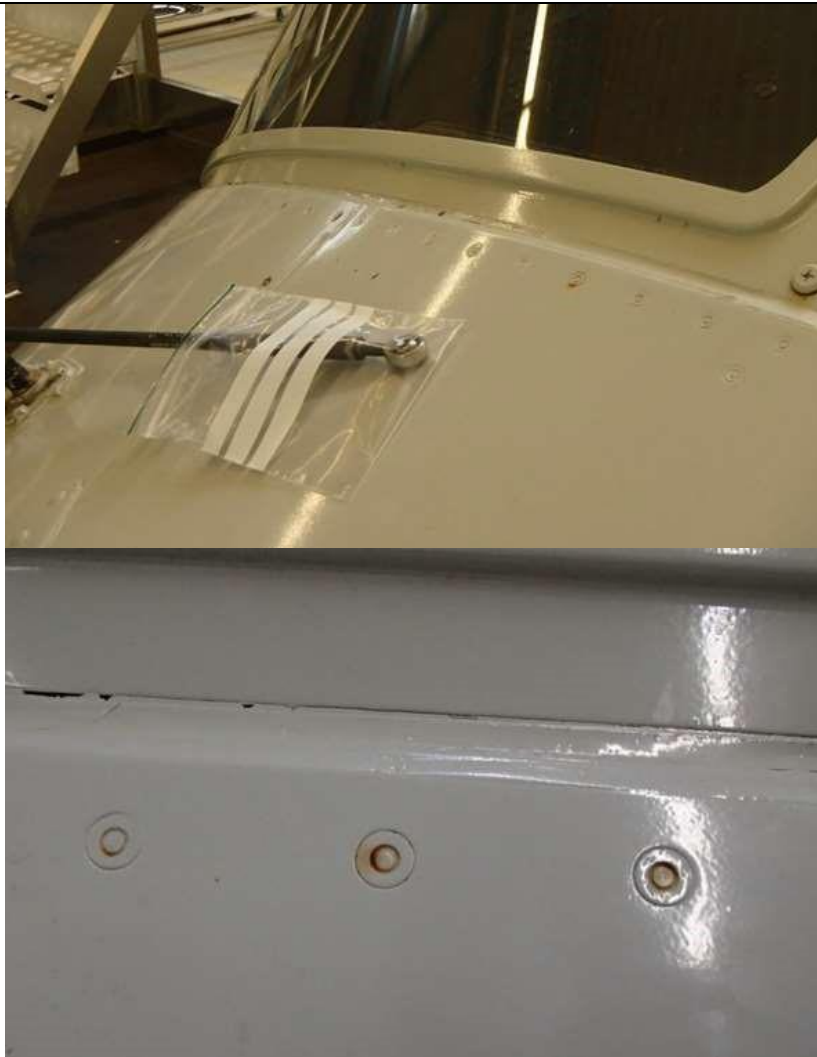
Corroding component	Steel fastening ring in titanium rivets
Component coupled to	Carbon fibre reinforced polymer (CFRP) fuselage (FWD part)
Corrosion cause	The CFRP fuselage has a glass outer ply to reduce galvanic coupling, but the rivets are installed dry. This leads to galvanic coupling of the rivets with the fuselage. The component with lowest potential corrodes when (salt) water can enter the rivets from the outside or from the inside. In the present case the corroding component is the steel ring that holds the stem of the rivet.

Preliminary analysis	Corrective and/or preventive measures	Wet installation of the rivets when they are replaced. Sealing of the rivets on the inside with a soft film corrosion preventive compound (CPC).
----------------------	---------------------------------------	--

SR / SB ?	SR 1-10302047 document ED_NH_227_009 describes the corrective measures to be taken to replace the rivets (drilling out of the corroded ones and replace them, use with oversized rivets if necessary). Note that replacement of the rivets is not a straightforward procedure. Some of the rivets are very hard to reach from the back side, hence supporting the CFRP skin during drilling out of the rivet is not possible. Unsupported drilling out may lead to delamination of the CFRP skin near the hole. Rivets in forward fuselage: ASNA 0341T05xx Rivets in window frame, below rubber seal: CR 7770S-04-03W
Classification	Insufficient corrosion protection

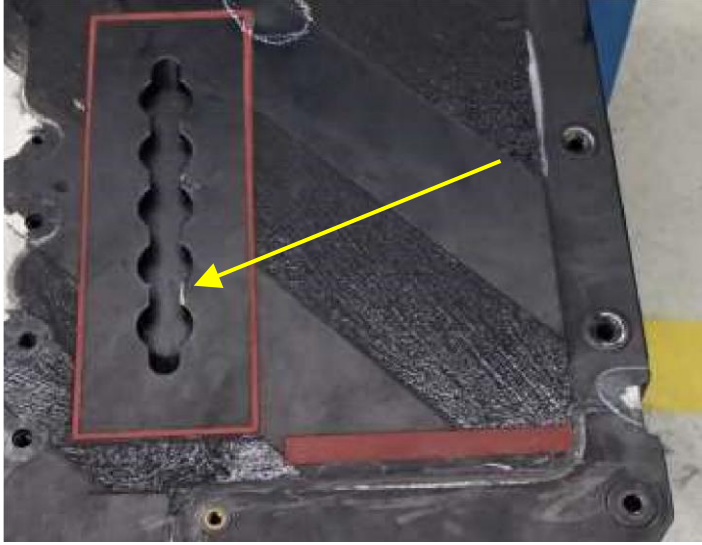
Corroding component		Aluminium tracks in the cabin floor
Component coupled to		Titanium fasteners, CFRP structure of the helicopter
Preliminary analysis	Failure cause	Paint on the tracks may get damaged because components are attached to the floor (mechanical damage). At those locations corrosion can start if these locations get into contact with salt water. Galvanic coupling of the aluminium tracks to the CFRP structure and titanium fasteners leads to accelerated corrosion of the aluminium. According to the IETP sealant should be applied, but this was not done.
	Corrective and/or preventive measures	Electrically insulate the aluminium from titanium and CFRP (wet installation of fasteners, use jointing compound between fasteners and aluminium and between aluminium and CFRP). Repair the paint when damaged. Apply temporary corrosion protection (hard film CPC).

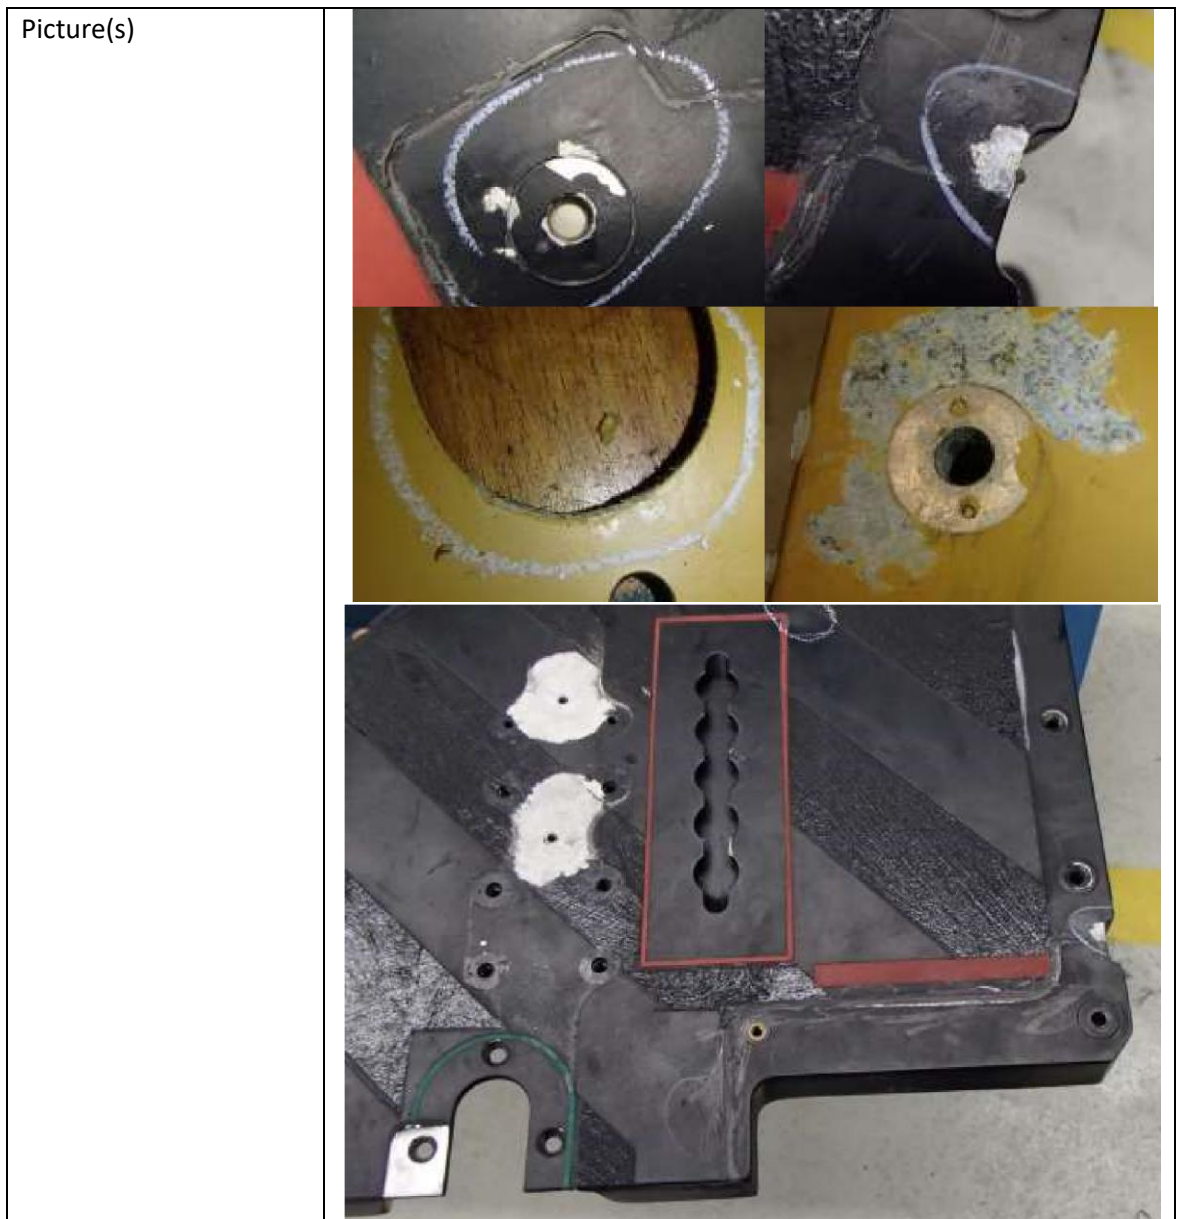
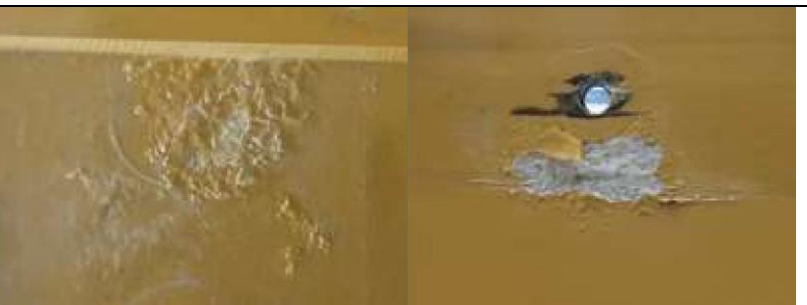
<p>Corroding component</p>	<p>Aluminium floor panels</p>
<p>Component coupled to</p>	<p>Titanium fasteners</p>

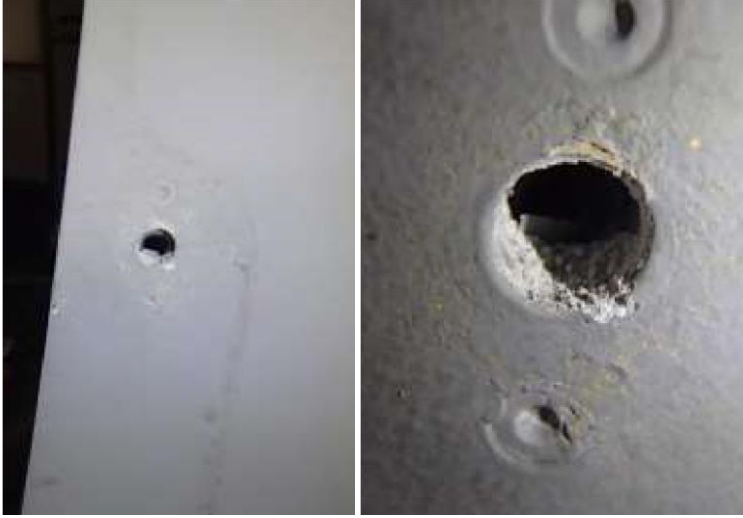
Corroding component		Corrosion on fasteners and frames at the inside of the doorpost
Component coupled to		CFRP fuselage
Preliminary analysis	Failure cause	The aluminium lower part of frame 7 is painted, but damage to the paint results in fast pitting corrosion. No paint/primer is applied to the inside of the doorpost, leaving the fasteners unprotected. If water enters the area, then corrosion can start. Galvanic coupling of the fasteners with the CFRP fuselage is an issue that can speed up corrosion.
	Corrective and/or preventive measures	Apply primer to the inside of the doorpost. Apply sealant or a hard film CPC to the fasteners at the inside of the doorpost.
	SR / SB ?	SR: 1-11542683
	Classification	Insufficient corrosion protection

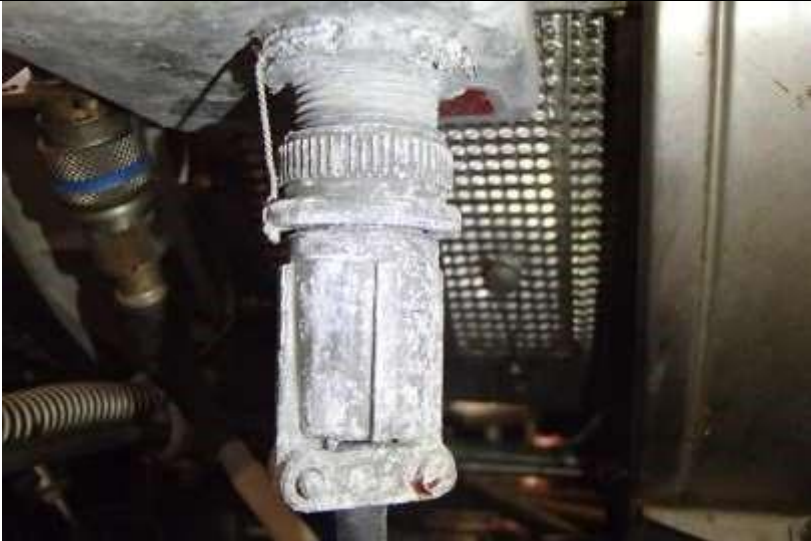
Corroding component	APU high energy unit connector	
Component coupled to	CFRP fuselage	
Preliminary analysis	Failure cause	Large amounts of moist and saline air are flowing past the connector, causing corrosion of the metal.
	Corrective and/or preventive measures	Protect the connector with a CPC or prevent the passing of moist and saline air. Insulate the connector by using sealant or jointing compound between connector and CFRP.
	SR / SB ?	
	Classification	Insufficient corrosion protection

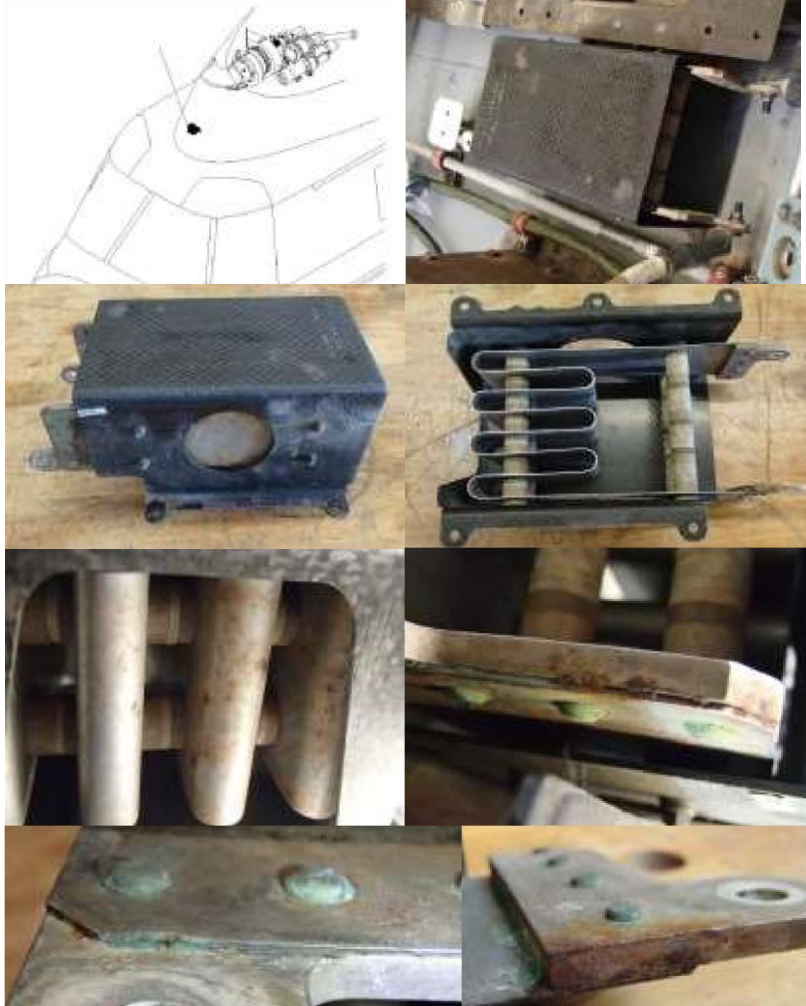
Corroding component	Start resistor assembly	
Component coupled to	CFRP	
Preliminary analysis	Failure cause	Corrosion of the resistor plate itself, corrosion between the resistor plate and the riveted terminal connector plate and corrosion of the rivets occurred due to the presence of salt water/moist air. The corrosion between the resistor plate and the connector is most probably crevice corrosion. The corrosion may/will lead to a high contact resistance and failure of the component.
	Corrective and/or preventive measures	Use dry air for cooling of the start resistor assembly. Apply a metallic corrosion protective coating over/on the joint to prevent crevice corrosion in the joint.
	SR / SB ?	SR 1-11355483
	Classification	Insufficient corrosion protection

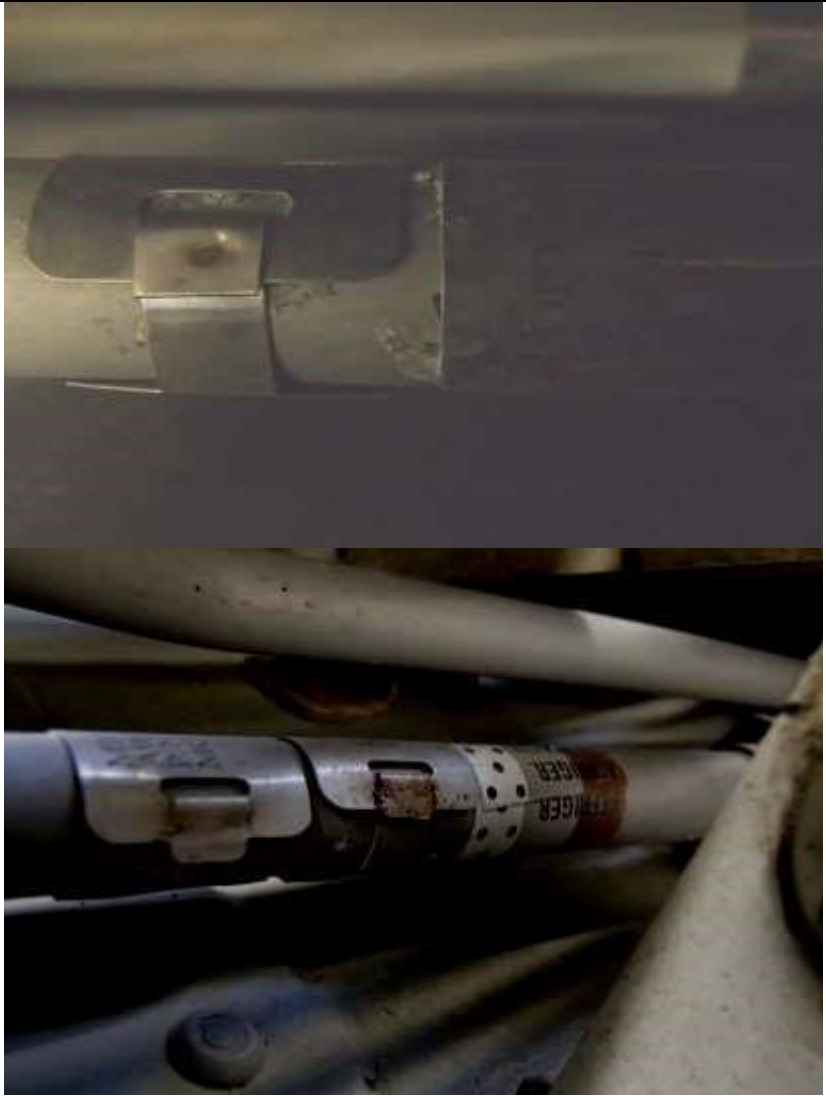
Corroding component	Tubing under ID tags on the upper deck	
Component coupled to	ID tags	
Preliminary analysis	Failure cause	Crevice corrosion occurs between the ID tags and the tubing when water enters. The corrosion is enhanced by the crevice and possibly by galvanic coupling of the aluminium tubing to more noble materials like the steel ID tags.
	Corrective and/or preventive measures	Use a sealant or jointing compound between the ID tags and the tubing to prevent crevice corrosion.
	SR / SB ?	
	Classification	Insufficient corrosion protection
Tail number	N227	
ATA nr	21-54	
NCage code	155099-1:A0076

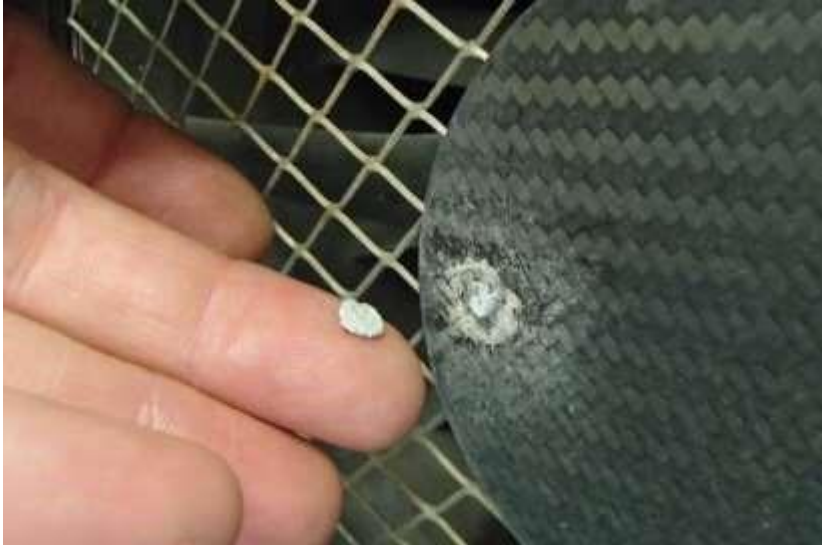
Corroding component		Aluminium rivets used for mounting the CFRP plates to the steel grid of the fan impeller guard of the environmental control system (ECS)
Component coupled to		Steel and CFRP
Preliminary analysis	Failure cause	Humid air containing salts passes through the grid and causes corrosion of the least noble metallic component, the aluminium rivets. Galvanic coupling of the aluminium rivets to the steel grid and CFRP plates accelerated the corrosion and led to failure of the rivets.
	Corrective and/or preventive measures	Application of grease or a CPC to the rivets prevents corrosion of the rivets. Note that the back side of the rivets should be protected as well, but cannot be reached easily. Use of stainless steel rivets that have a lower galvanic couple with CFRP. Use of sealant or jointing compound between the different materials when assembling the grid & plate.

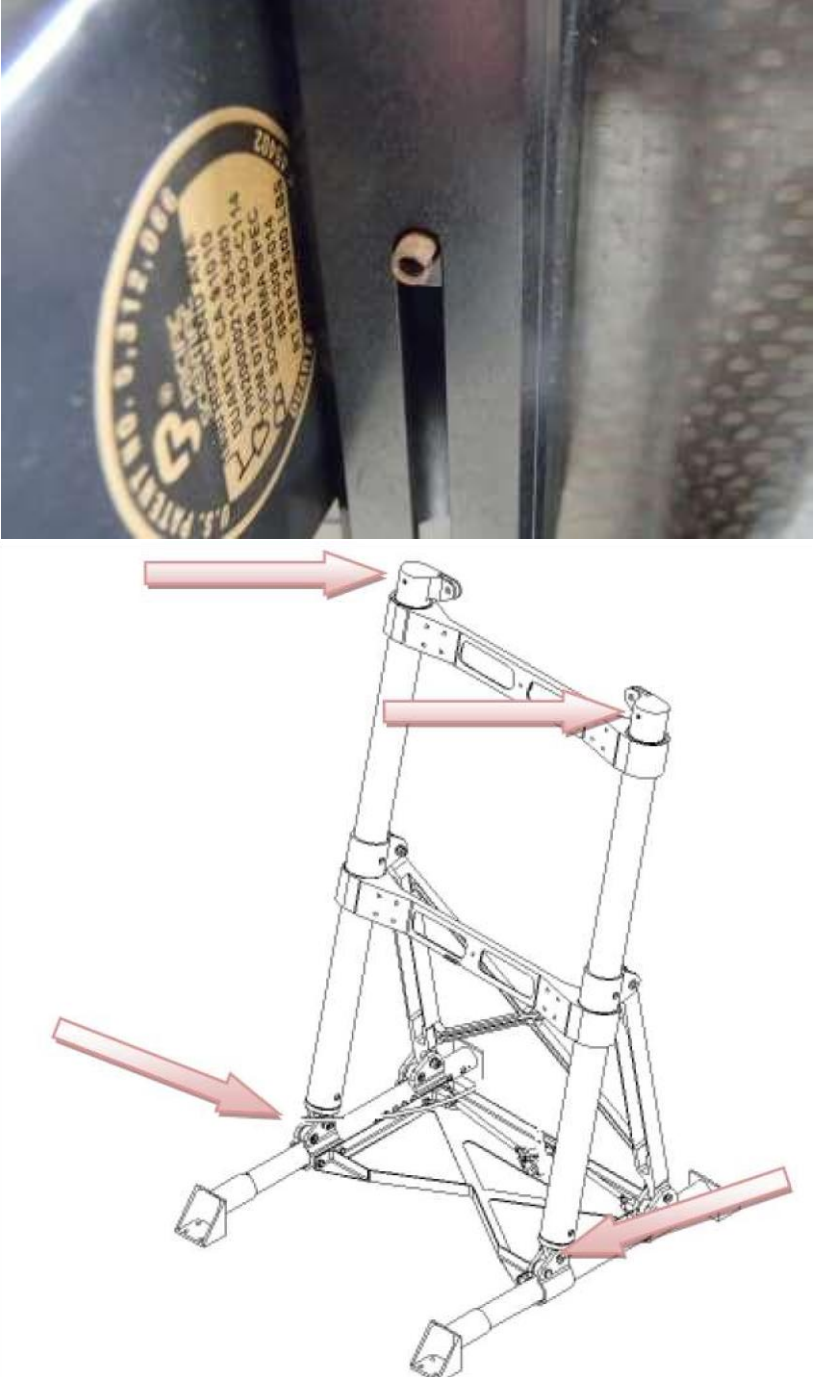
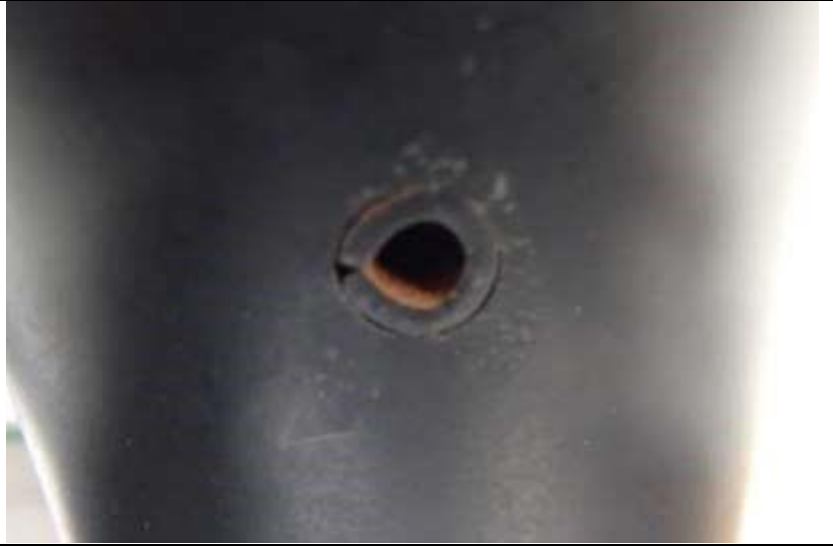
Corroding component	Dowel pins in cockpit seats	
Component coupled to	Several materials	
Preliminary analysis	Failure cause	Dowel pins are used to assemble the cockpit seats. These pins are not corrosion resistant and are unprotected. Note that these pins are used on several locations in the helicopter and all of them are corroding.
	Corrective and/or preventive measures	Use dowel pins with better corrosion resistance. Painting of the pins will not solve the problem because the paint will be scraped off partially during installation. Sealing is unwanted because the sealant hinders visual inspection for corrosion. Apply a transparent soft film CPC to the dowel pins after installation.
	SR / SB ?	
	Classification	Wrong materials selection
Tail number	N233, N227	
ATA nr	25-12	
NCage code	S251A20A1002:F0210

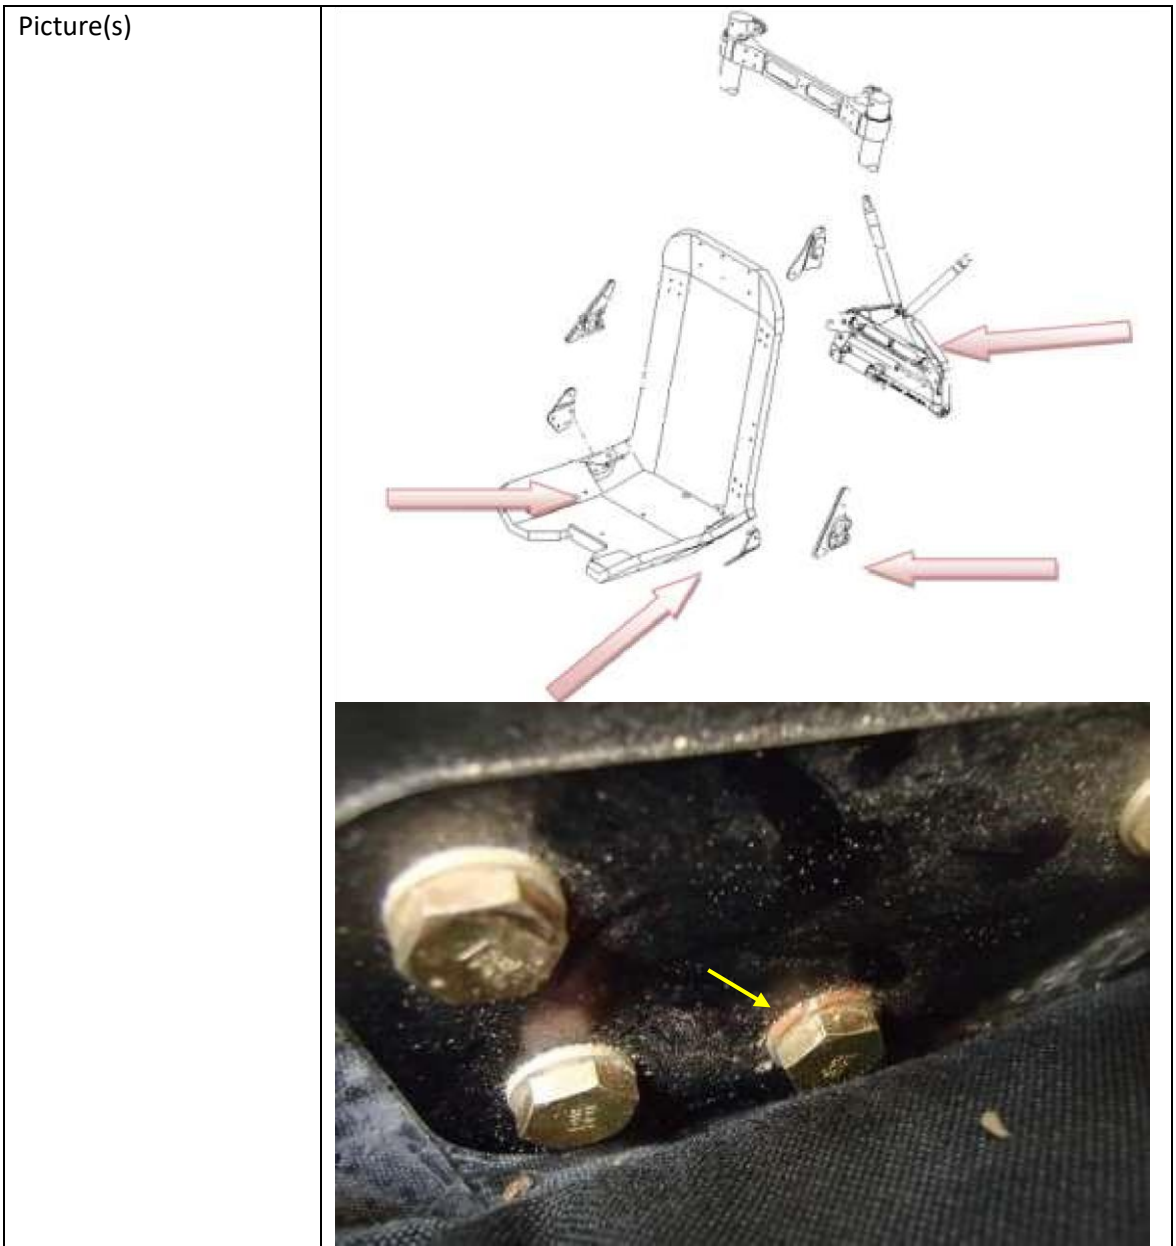
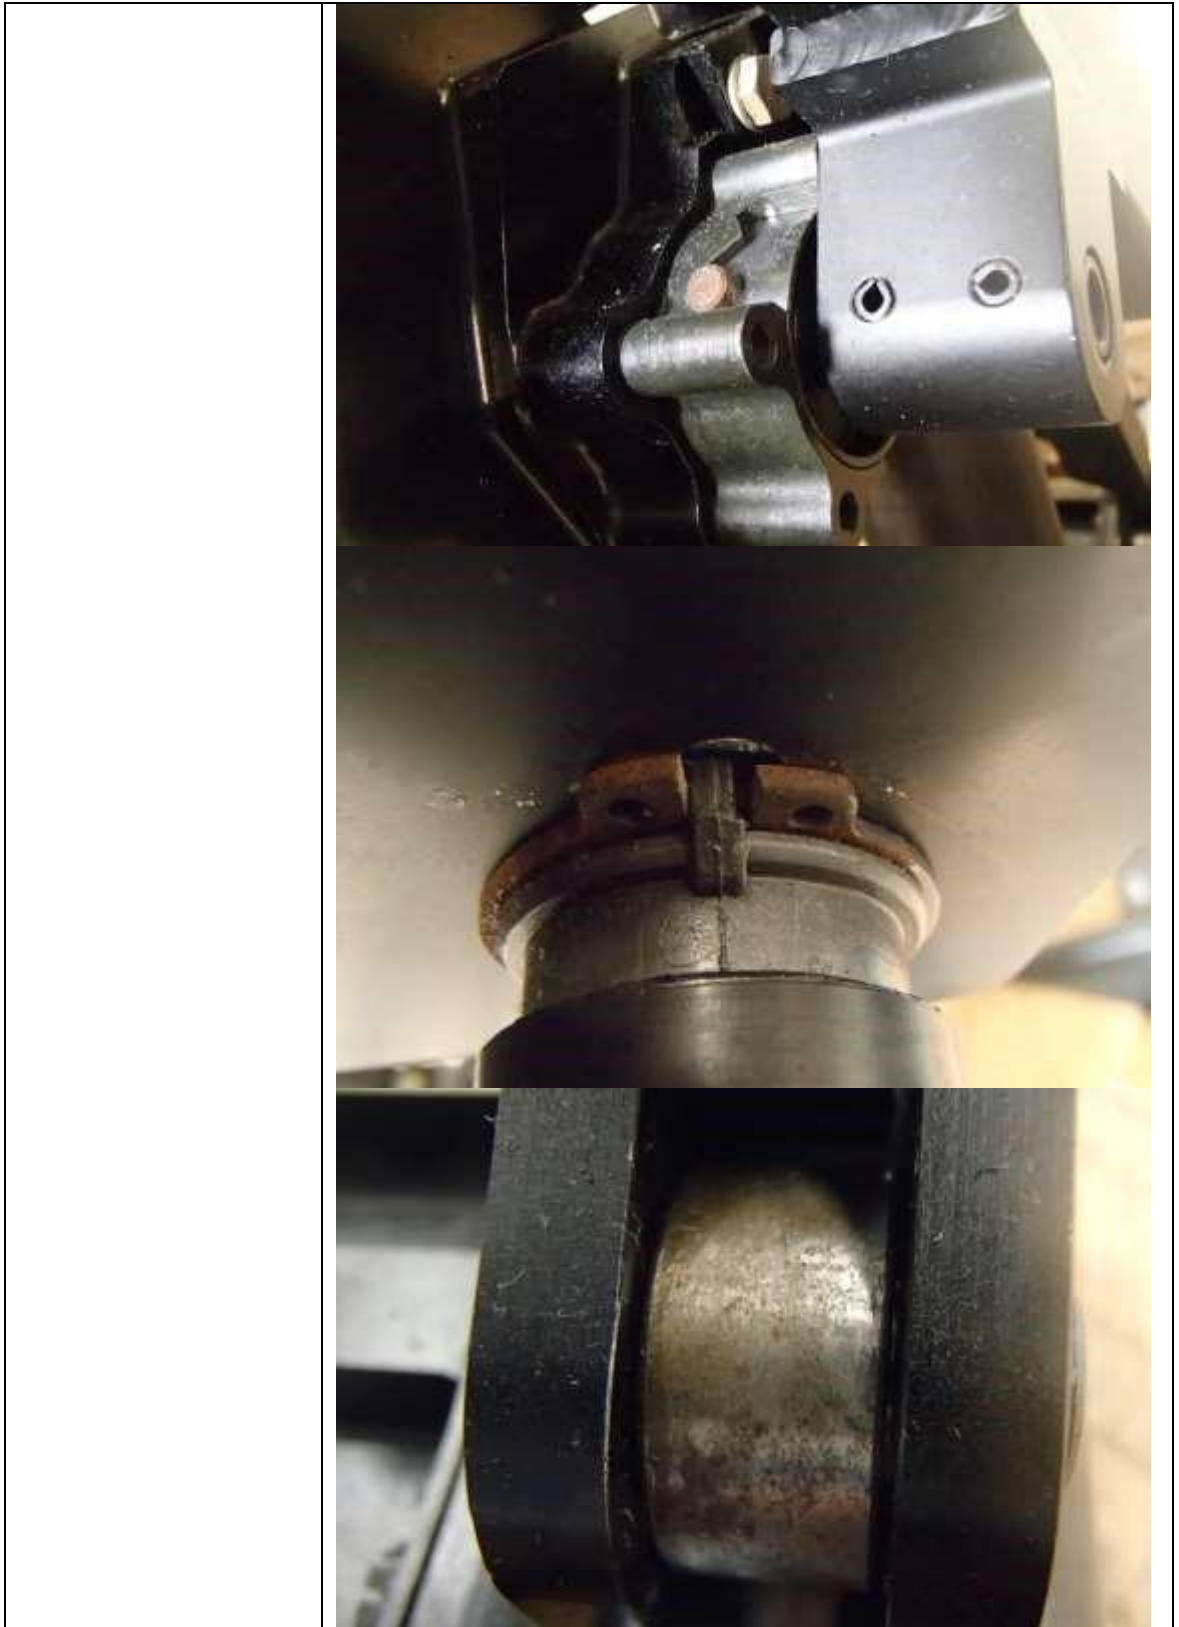
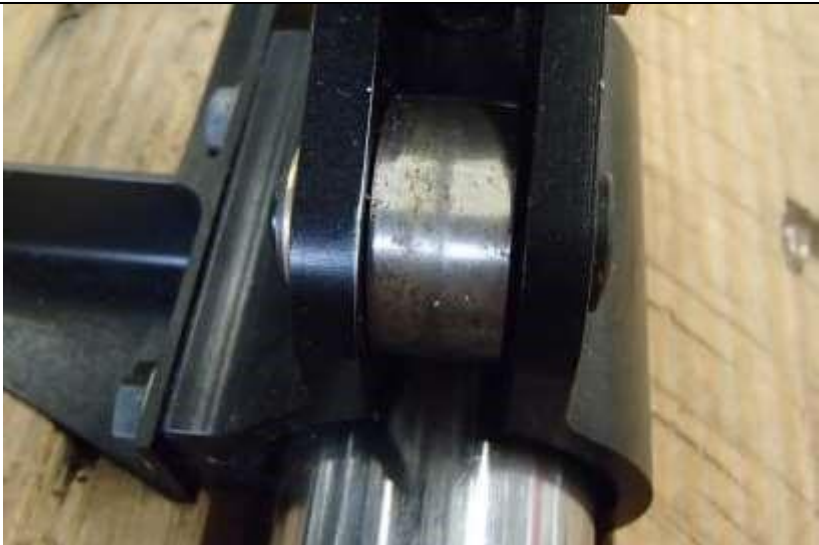
Corroding component	Cockpit seats, several steel parts	
Component coupled to	Several materials	
Preliminary analysis	Failure cause	Several bare steel components in the cockpit seats show corrosion. The seats are bolted onto the CFRP cockpit floor. Exposure to salt water is not anticipated in the design, but occurs when flying above sea with the sliding door open.
	Corrective and/or preventive measures	Protect the bare metal components with a CPC (hard film can be used on non-moving parts, soft film should be used for moving parts). Mount the cockpit seats with jointing compound to prevent galvanic coupling with the CFRP floor.
	SR / SB ?	
	Classification	Insufficient corrosion protection

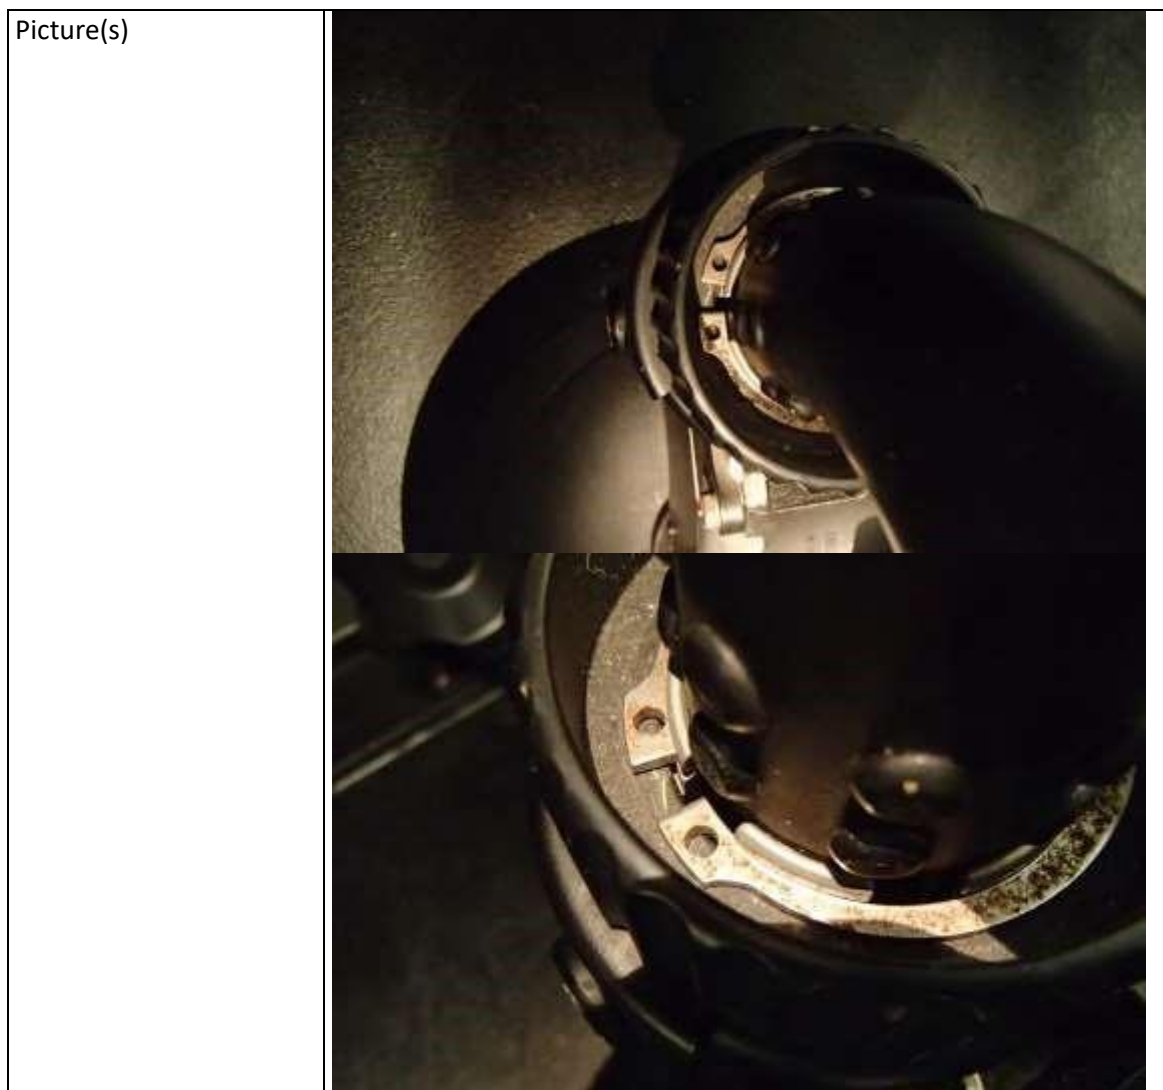
Corroding component	Spring in the cyclic stick	
Component coupled to	Not applicable	
Preliminary analysis	Failure cause	Salt water spray caused water on the spring of the cyclic stick. This water was trapped and caused corrosion of the spring. The spring has little to no corrosion protection, most probably because salt water spray was expected to be absent.
	Corrective and/or preventive measures	Apply CPC to the spring to protect it from corrosion.
	SR / SB ?	SR 1-11070181
	Classification	Insufficient corrosion protection

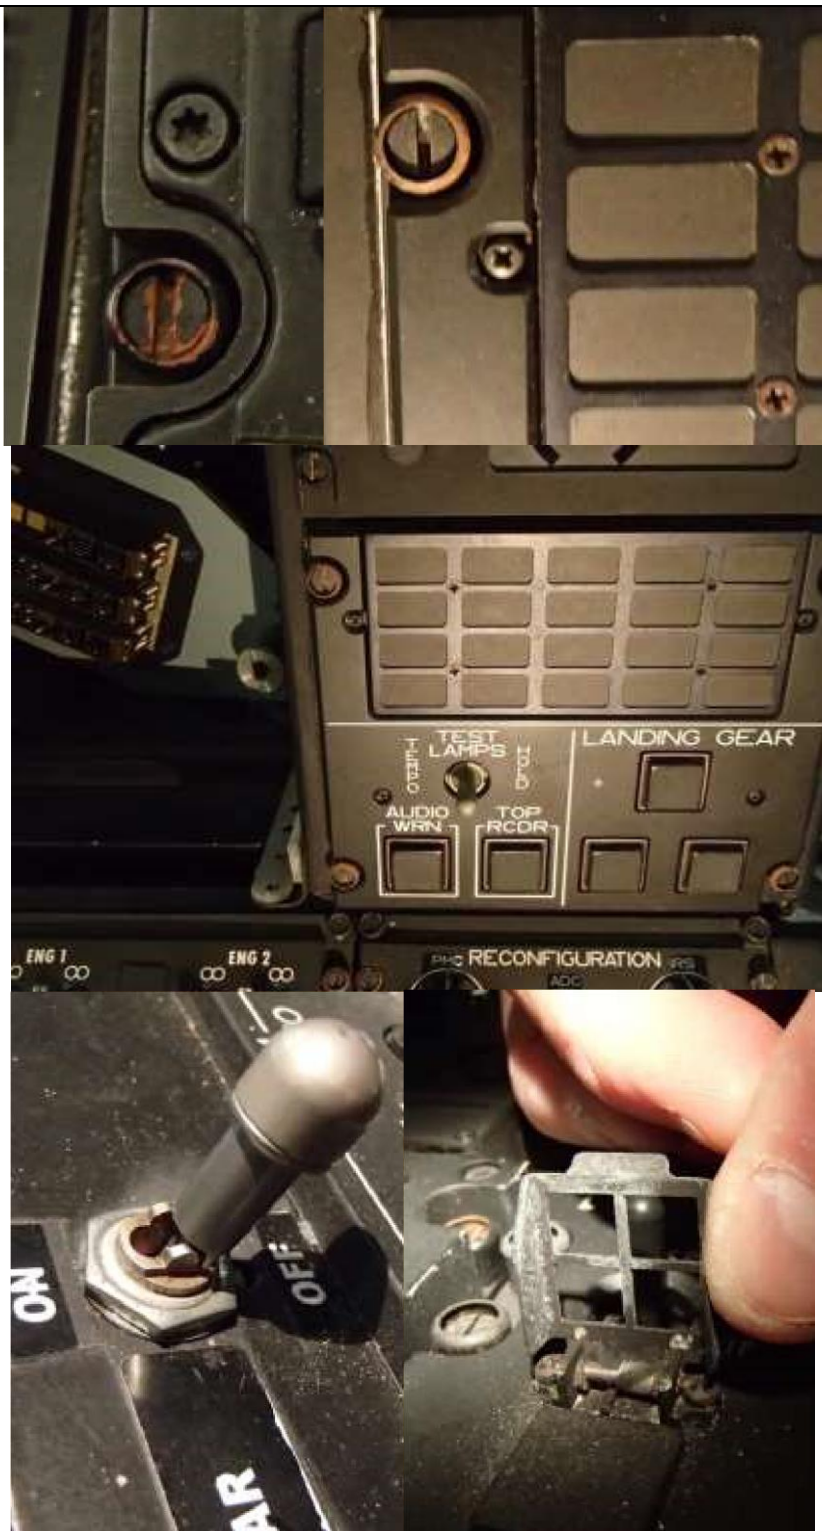
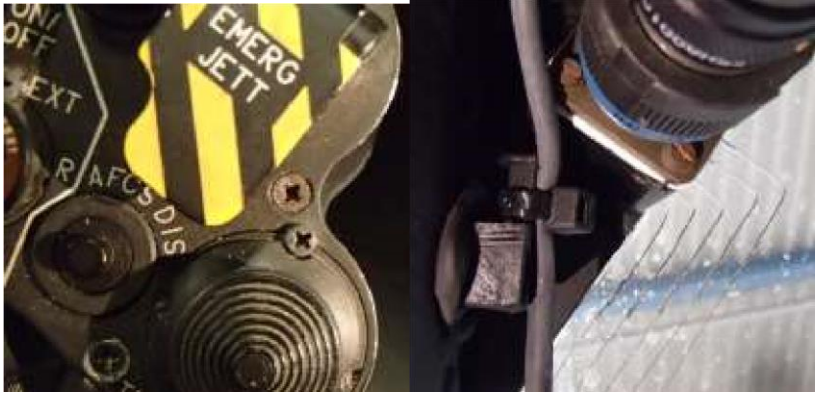
Corroding component	Bolts and nuts fastening the instrument panels, protections caps and switches on the instrument panel	
Component coupled to	CFRP fuselage structure	
Preliminary analysis	Failure cause	Water spray enters the cockpit during operations above sea with the (right-hand) sliding door open. This leads to corrosion of the fasteners and switches of the instrument panel. Corrosion may be accelerated by galvanic coupling to the CFRP structure of the helicopter. The air circulation system circulates air that contains (some) salt. This adds in the corrosivity of the environment.
	Corrective and/or preventive measures	Protect the bolts and nuts with a hard-film CPC or paint after mounting of the instrument panels. Install bolts wet.
	SR / SB ?	SR 1-11069371
	Classification	Insufficient corrosion protection
Tail number	N227	
ATA nr	25-12	
NCage code	No item number for attachment brackets:F0210

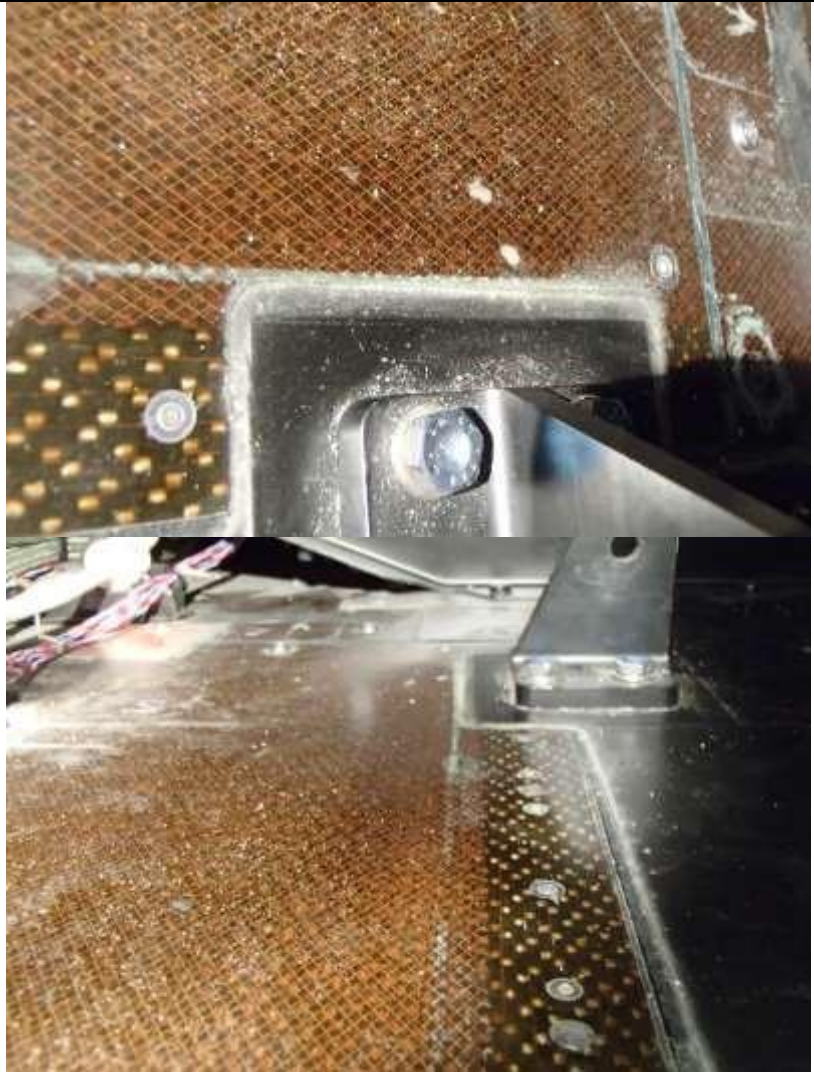
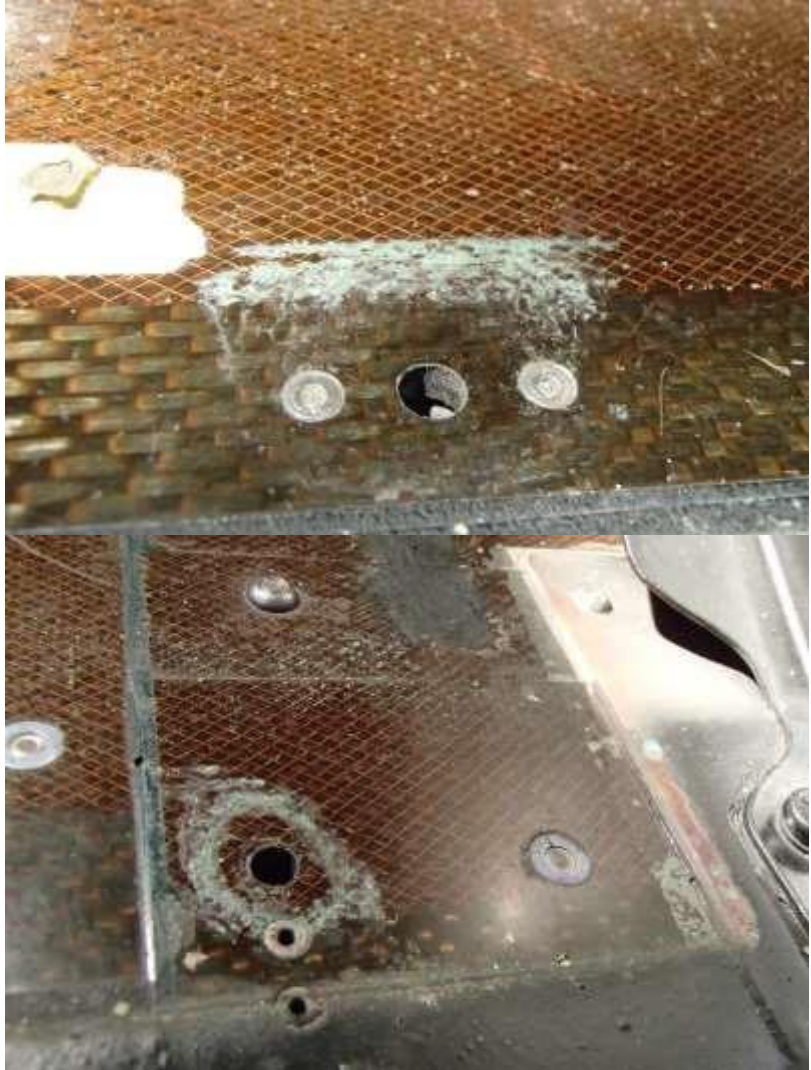
Corroding component	Cockpit floor where seats were bolted	
Component coupled to	CFRP support structure, metal seat and fasteners	
Preliminary analysis	Failure cause	Corrosion of fastening materials (bolts and nuts) and bushings due to salt water spray and galvanic coupling to more noble CFRP cockpit floor.
	Corrective and/or preventive measures	Installation of metallic bolts into CFRP should be done wet, with sealant, CPC or jointing compound to insulate the metal from the CFRP.
	SR / SB ?	
	Classification	Insufficient corrosion protection

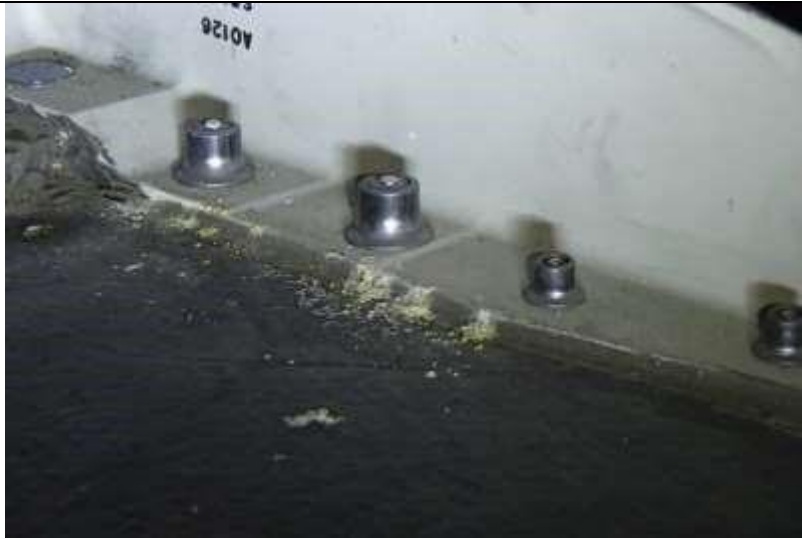
Corroding component		Aluminium frame in intermediate structure
Component coupled to		Titanium fasteners and CFRP skin
Preliminary analysis	Failure cause	Sealant is placed next to the joint instead of over the joint. This allowed corrosion to start when water could reach the joint. Galvanic coupling of the aluminium frame to the CFRP skin accelerated the corrosion. Water was present because draining of water is not ideal in the intermediate structure
	Corrective and/or preventive measures	Apply sealant at the correct place, namely over the joint. Improve draining of water.
	SR / SB ?	
	Classification	Wrong manufacturing

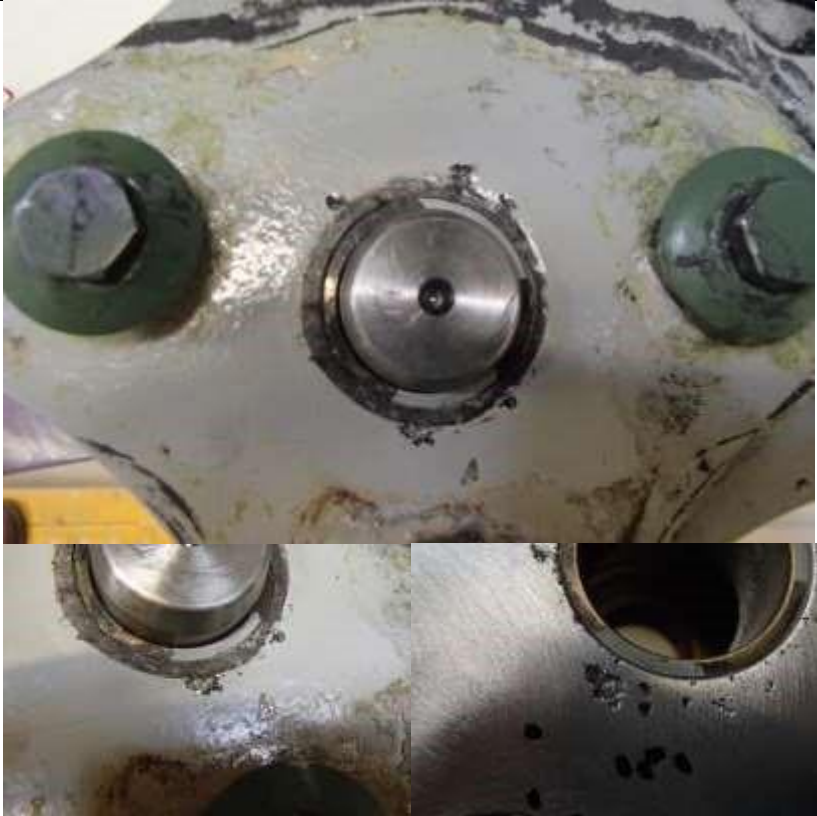
Corroding component	Corrosion of aluminium lower hinge beam	
Component coupled to	Bronze bushing and steel pins	
Preliminary analysis	Failure cause	Galvanic coupling of the aluminium beam to more noble steel pins and bronze bushings lead to accelerated corrosion of the beam next to the bushings. Installation of the bushings leads to electrical contact between the bushing and the frame. Damage to the coating on the aluminium frame enables galvanic corrosion.
	Corrective and/or preventive measures	Application of a sealant over the paint to protect the paint from chipping and to seal the contact area between the beam and the bushing.
	SR / SB ?	
	Classification	Insufficient corrosion protection

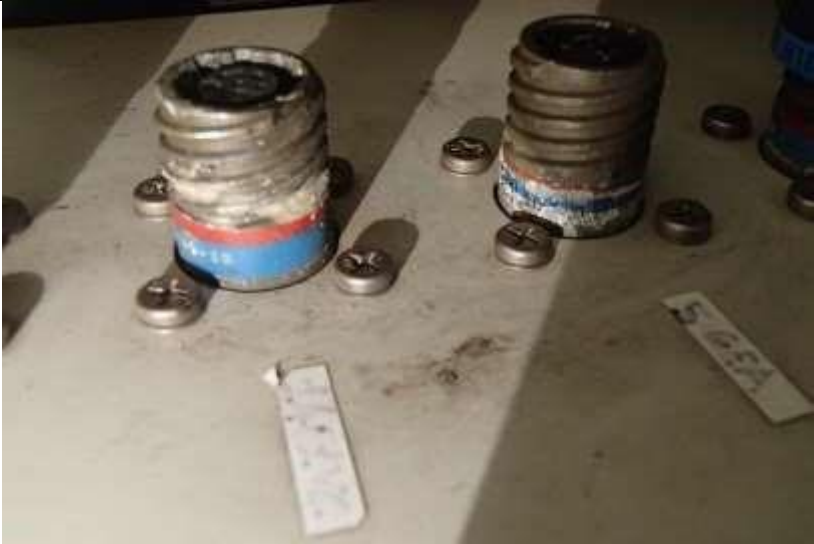
Corroding component		Corrosion of connectors in tail pylon
Component coupled to		CFRP structure, titanium fasteners
Preliminary analysis	Failure cause	The connectors are coupled to the CFRP structure which results in galvanic corrosion if the connectors get into contact with water.
	Corrective and/or preventive measures	Apply a soft film CPC on the connectors and install them with sealant between the connectors and the CFRP. Protect the connectors with a cap.
	SR / SB ?	
	Classification	Insufficient corrosion protection

<p>Corrective and/or preventive measures</p>	<p>Application of a CPC or jointing compound to reduce the risk of corrosion. It is preferred that rinsing of the helicopter after a mission on sea is done before folding the tail. However, procedures prescribe that the rotor blades and tail are folded within 20 minutes after landing on a ship (at high sea state). Additional drainage holes should have been implemented to allow draining of water when the tail is folded.</p>
<p>SR / SB ?</p>	
<p>Classification</p>	<p>Wrong design Insufficient corrosion protection</p>
<p>Tail number</p>	<p>N227</p>
<p>ATA nr</p>	<p>55-31</p>
<p>NCage code</p>	<p>S553F1150000:H1822</p>
<p>Picture(s)</p>

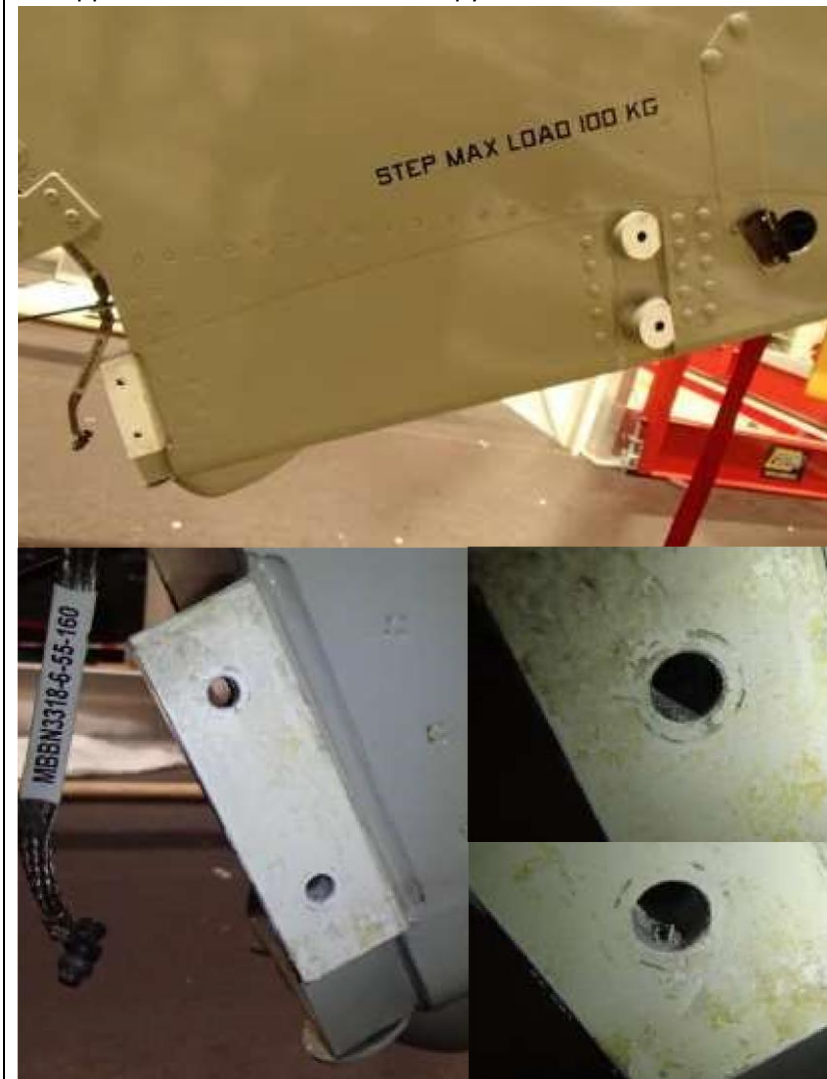
<p>Picture(s)</p>	<p>Aft upper and lower attachment tail pylon</p>

<p>– reasonable corrosion</p>   <p>Aft upper (l) and lower (r) attachment inboard view moderate corrosion)</p>
-------------------	--

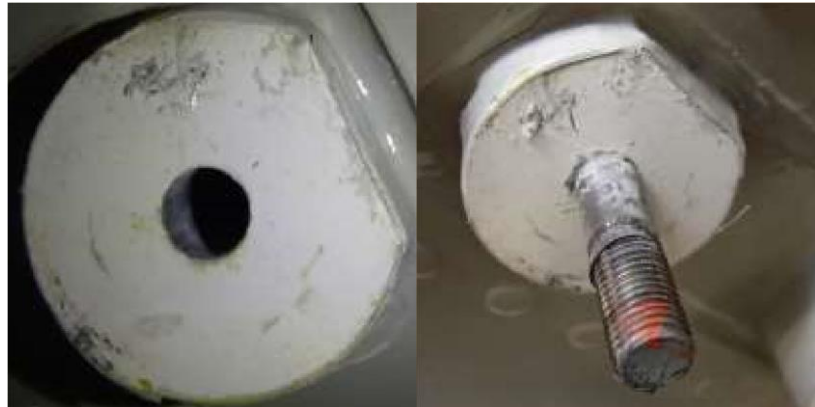
FWD upper attachment tail pylon with jammed bolt (r)
