COMPANY CONFIDENTIAL  
NLR-CR-2014-129

## Inventory of corrosion occurrences on two NH90 helicopters after operation in tropical and saline environment

L. 't Hoen-Velterop

Nationaal Lucht- en Ruimtevaartlaboratorium  
National Aerospace Laboratory NLR

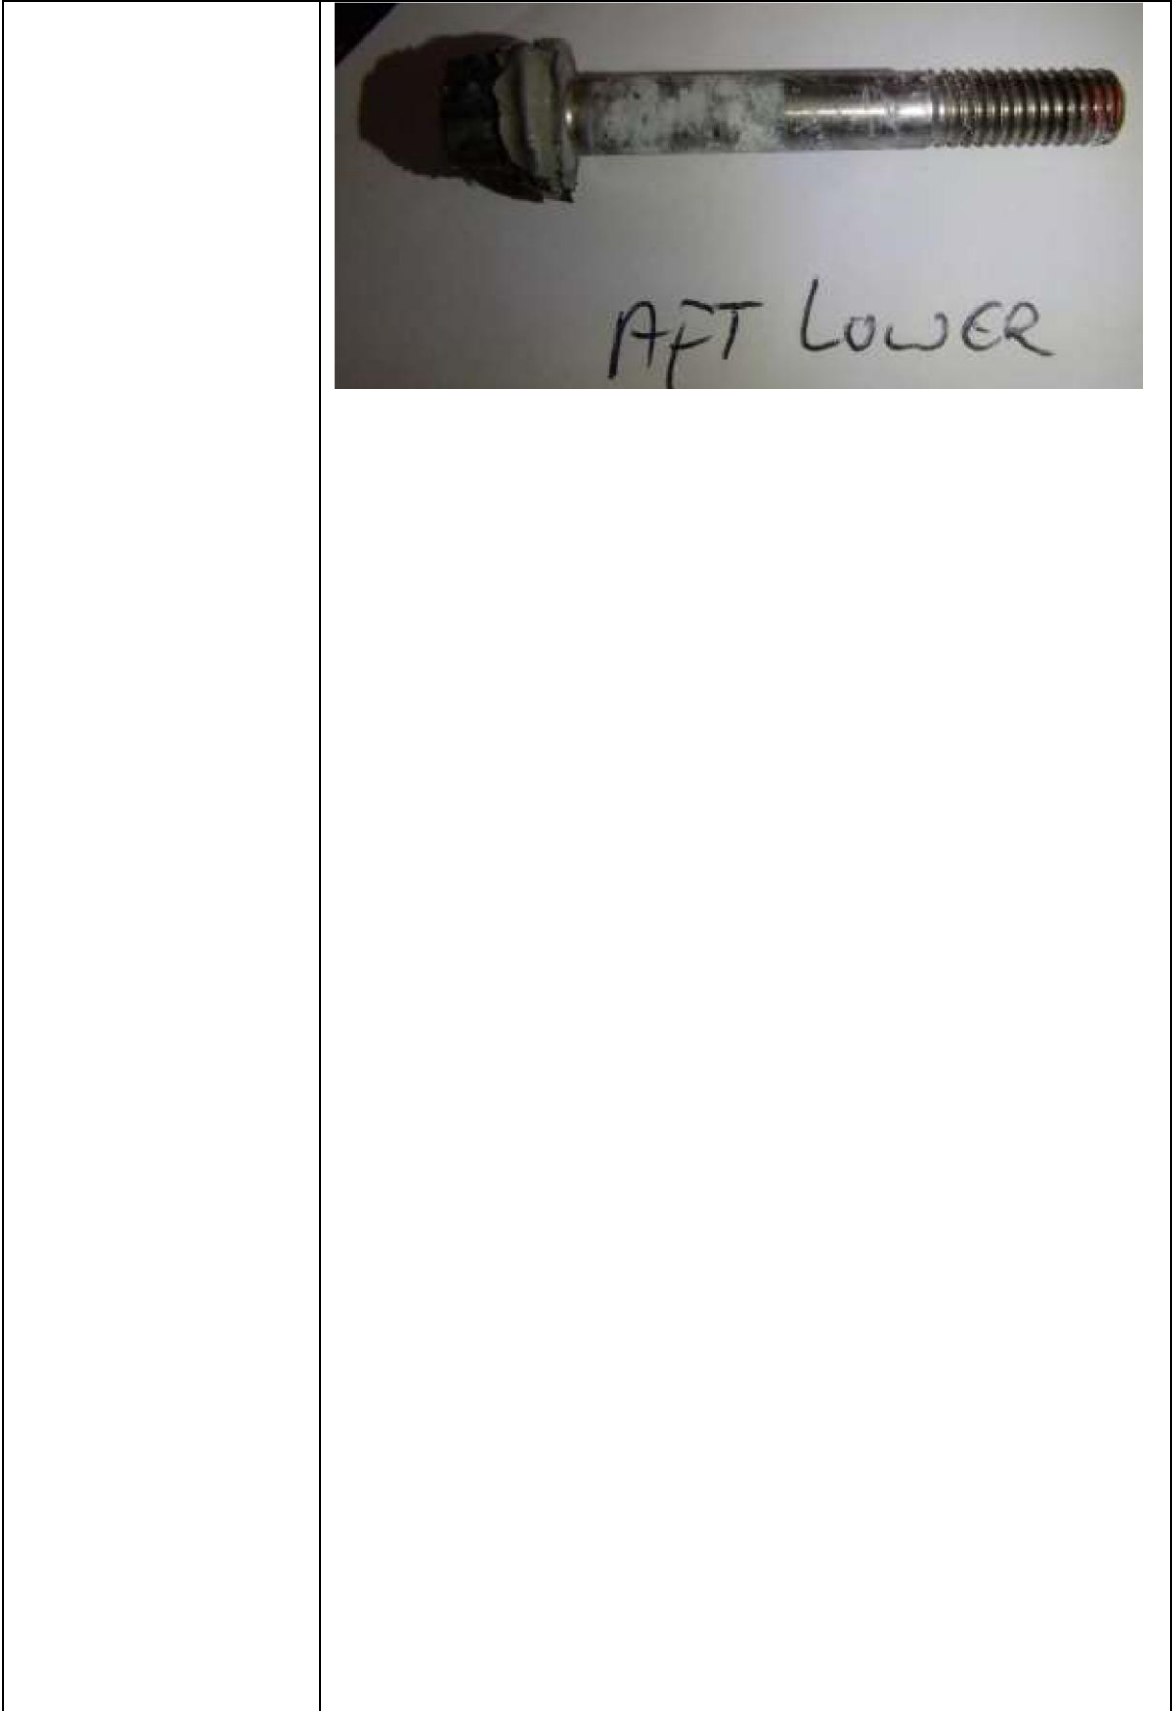
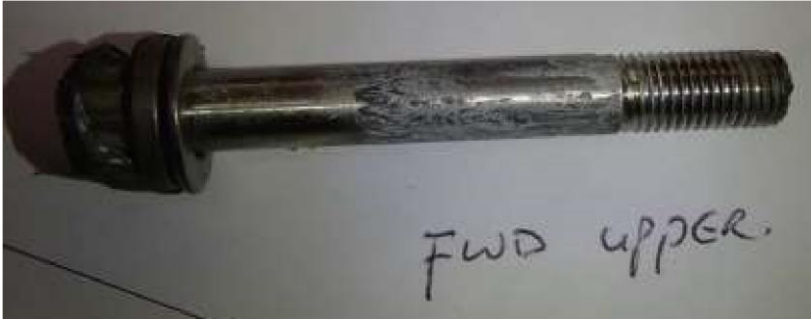
Tail pylon attachment bolts after removal
Corroding component		Attachment assembly (bolts and lugs) of horizontal stabilizer – tail pylon side
Component coupled to		Aluminium lug coupled to steel bolts and CFRP structure
Preliminary analysis	Failure cause	Three of the four bolts were jammed in the lugs due to corrosion. Crevice corrosion of the aluminium lug is accelerated by galvanic coupling of the lug to steel bolts and possibly also to the CFRP structure of the tail and the horizontal stabilizer. Sealant was applied on the bolt head, but not the whole circumference of the bolt was covered. The sealant showed cracking. The incomplete sealing and cracks in the sealant allowed water to enter the area between the bolt and the lug, which led to corrosion of the lug.
	Corrective and/or preventive measures	The manufacturer should decide whether the lugs can be cleaned and fitted with a bushing or oversized bolt or that the whole parts need to be replaced. Application of jointing compound in the hole of the lug, to prevent electrical contact between the steel bolt and the aluminium lug and to prevent water ingress in the area between bolt and lug. Proper sealing of the bolt heads to prevent water ingress along the bolt.

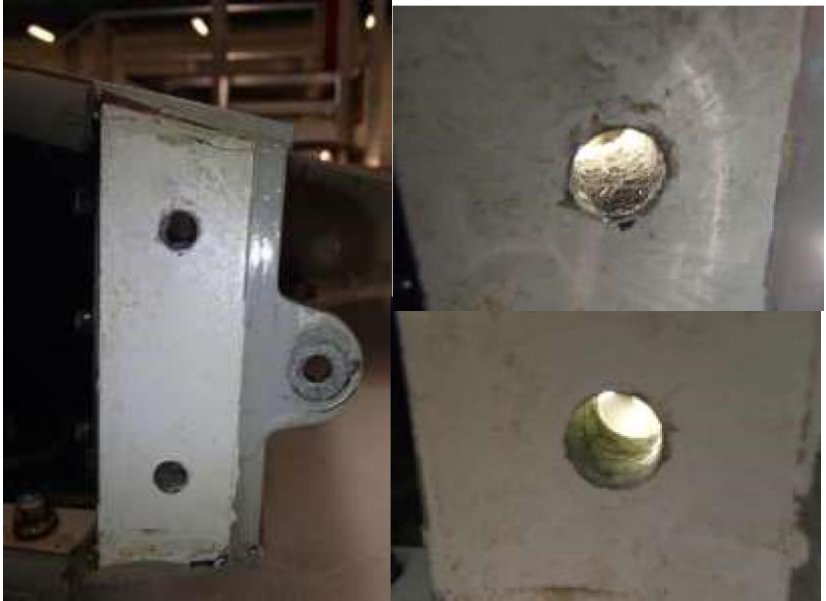
Aft attachments
Corroding component	Attachment assembly (bolts and lugs) of horizontal stabilizer – horizontal stabilizer side	
Component coupled to	Aluminium lug coupled to steel bolts and CFRP structure	
Preliminary analysis	Failure cause	Three of the four bolts were jammed in the lugs due to corrosion. Crevice corrosion of the aluminium lug is accelerated by galvanic coupling of the lug to steel bolts and possibly also to the CFRP structure of the tail and the horizontal stabilizer. Sealant was applied on the bolt head, but not the whole circumference of the bolt was covered. The sealant showed cracking. The incomplete sealing and cracks in the sealant allowed water to enter the area between the bolt and the lug, which led to corrosion of the lug.
	Corrective and/or preventive measures	The manufacturer should decide whether the lugs can be cleaned and fitted with a bushing or oversized bolt or that the whole parts need to be replaced. Application of jointing compound in the hole of the lug, to prevent electrical contact between the steel bolt and the aluminium lug and to prevent water ingress in the area between bolt and lug. Proper sealing of the bolt heads to prevent water ingress along the bolt.

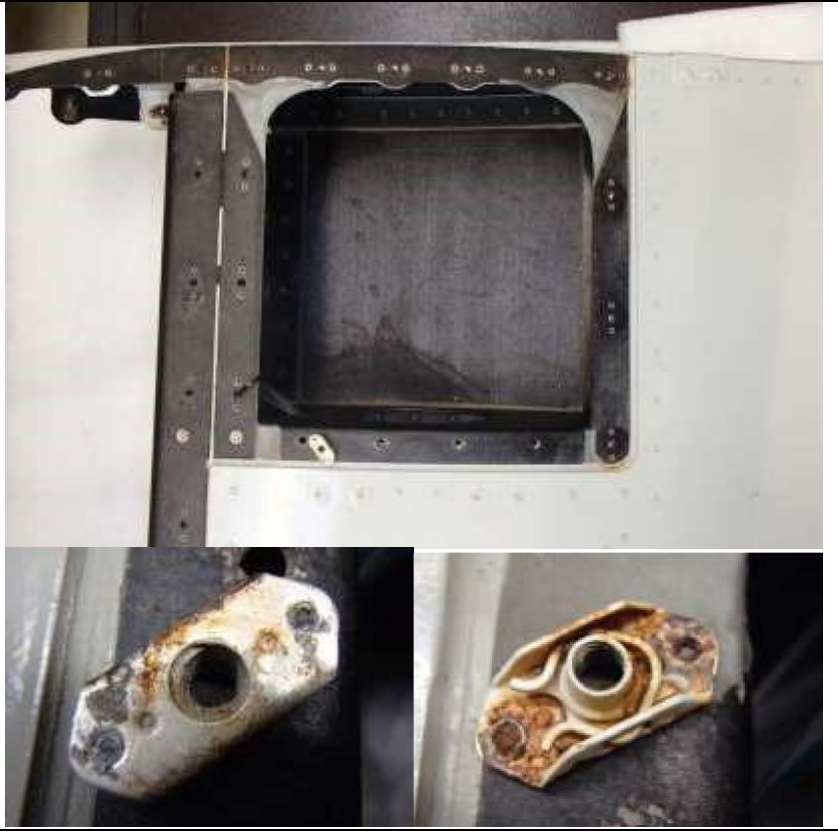
Corroding component		Rivet lock nuts closing the hatch in the horizontal stabilizer; the panel edge	
Component coupled to		CFRP skin	
Preliminary analysis	Failure cause	Water could enter the horizontal stabilizer and caused corrosion. The galvanic coupling of steel lock nut and its aluminium attachment pins to the CFRP structure accelerated the corrosion. The corrosion led to weakening of the attachment pins and eventual shearing of the pins when it was tried to open the hatch for maintenance. The paint on the edge of the hatch was damaged, which led to corrosion of the exposed aluminium.	
	Corrective and/or preventive measures	Apply sealant or jointing compound between the nut and the CFRP structure and apply sealant over the nut to protect it from salt water.	
	SR / SB ?		
	Classification	Insufficient corrosion protection	
Tail number		N227	
ATA nr		55-11	
NCage code		S551F0000000:H1822

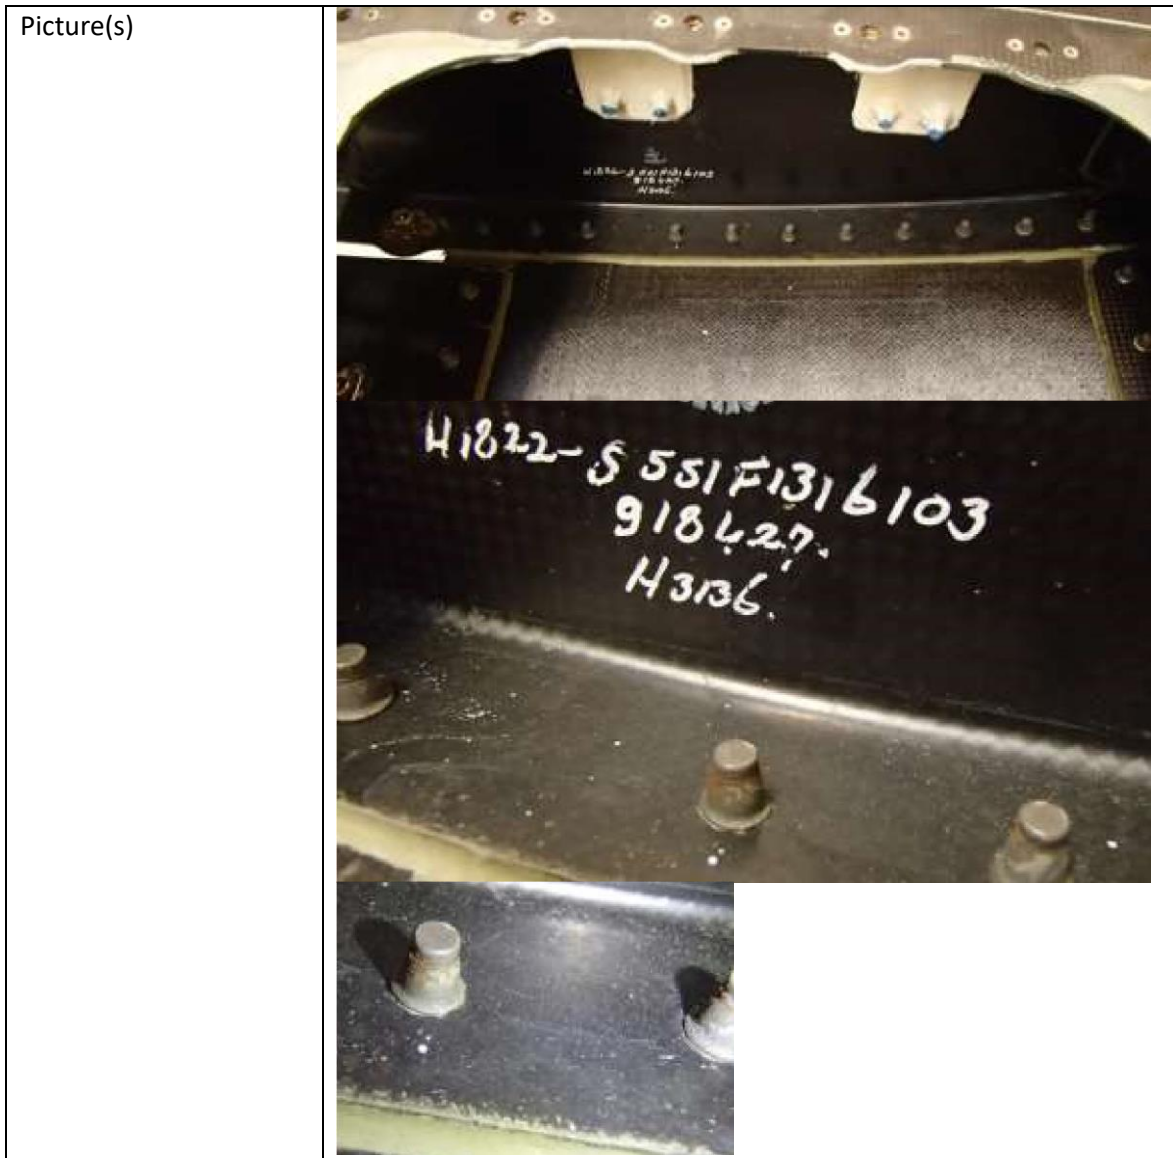
Corroding component	Rivet in the horizontal stabilizer	
Component coupled to	CFRP skin	
Preliminary analysis	Failure cause	Steel of the rivets started to corrode when the protective coating is damaged/consumed. Coupling to the CFRP structure enhanced the corrosion.
	Corrective and/or preventive measures	Replace the corroded rivets. Install the rivets wet and protect them with sealant or a CPC.
	SR / SB ?	
	Classification	Insufficient corrosion protection

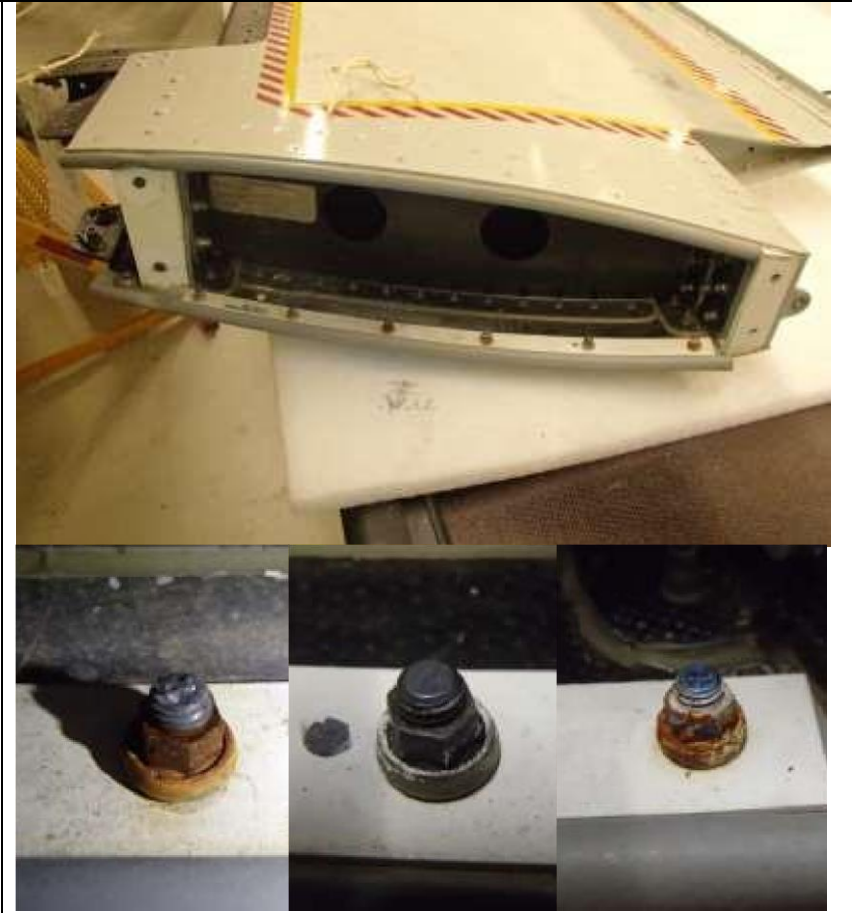
Corroding component		Steel nuts in the horizontal stabilizer
Component coupled to		CFRP structure and titanium bolts
Preliminary analysis	Failure cause	<p>The top of the bolts are protected by sealant but the nuts are left unprotected while they are coupled electrically to the CFRP structure. Entry of salt water resulted in galvanic corrosion of the steel components.</p> <p>The detail photograph of the bolt &amp; nut shown in the right hand image indicates that silver plated nuts are used. However, the silver plating is damaged and the steel nut underneath corrodes preferentially. The corrosion is accelerated by galvanic coupling of the steel nut to the silver plating and the CFRP structure.</p>
	Corrective and/or preventive measures	Apply sealant over the whole assembly instead of the bolt end only. Use jointing compound between the washers and the nuts and the CFRP skin.
	SR / SB ?

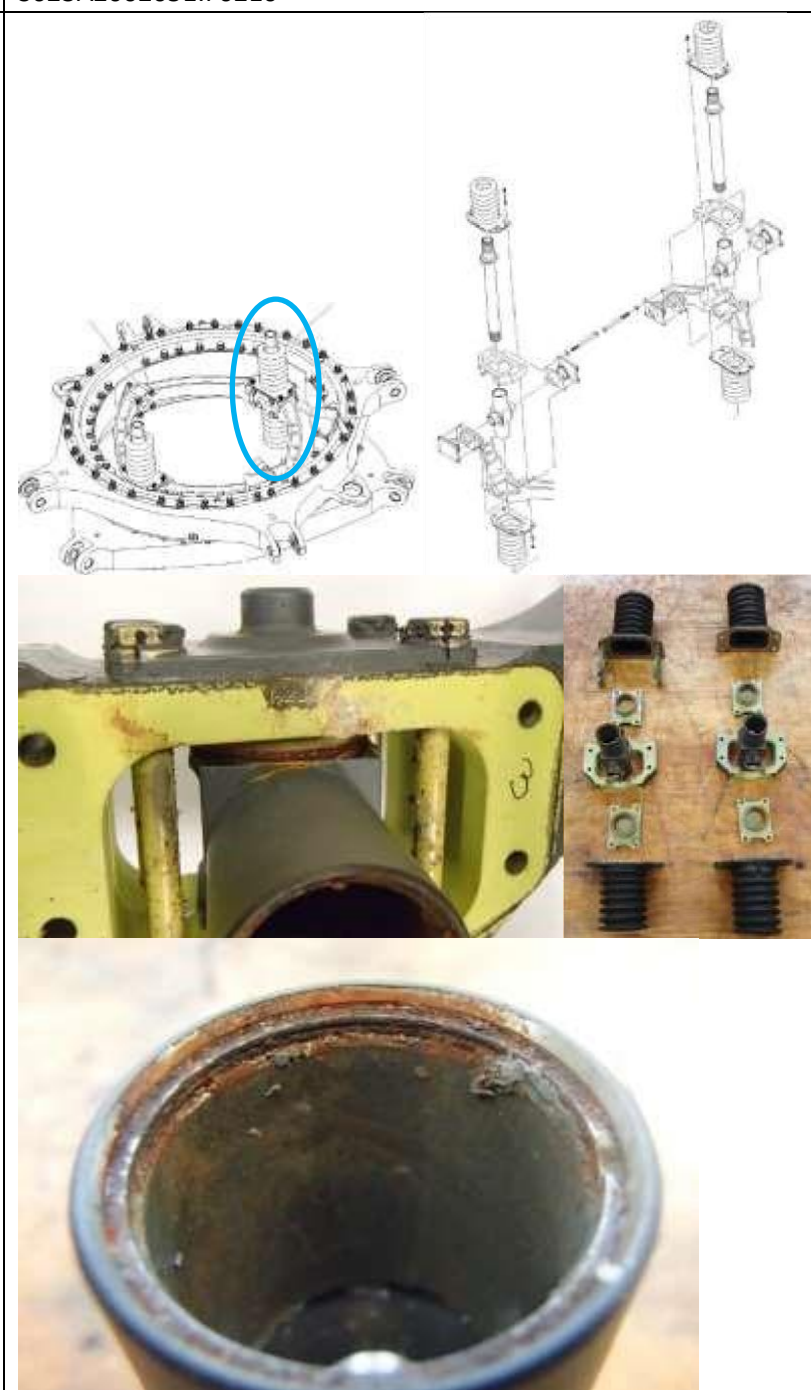
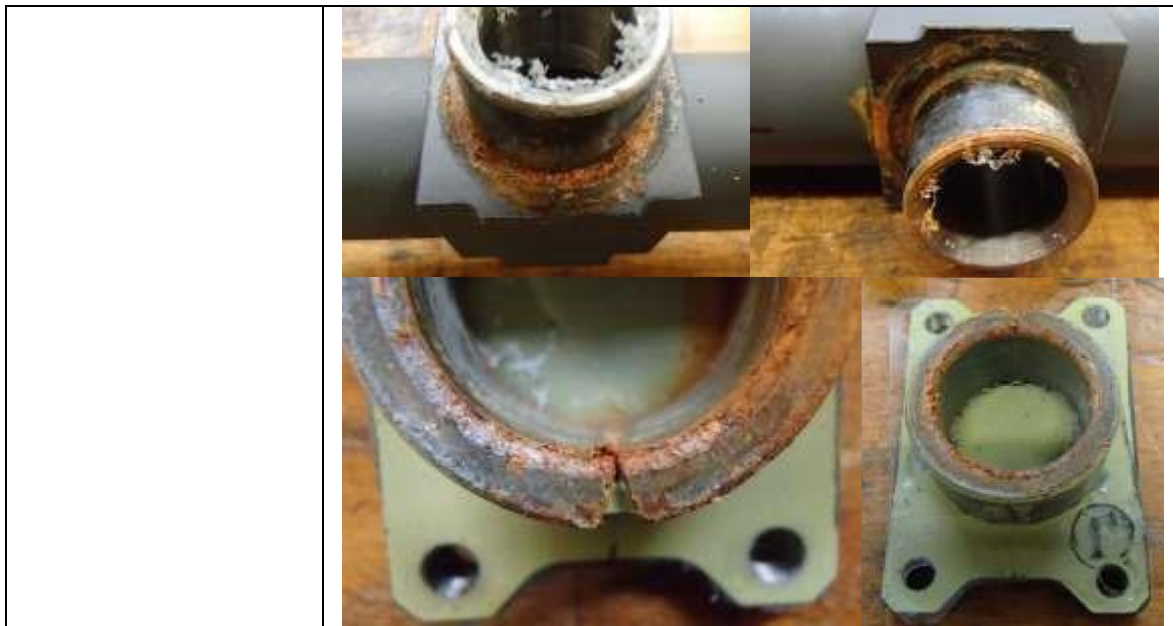
Corroding component	Swash plate component: column body	
Component coupled to	Not applicable	
Preliminary analysis	Failure cause	All steel components show signs of rust. The components have remnants of the self-lubricating coating that is used to reduce maintenance on the rotor head. The steel placeholder ring is corroding. The self-lubricating coating provides insufficient corrosion protection to the ring. Water can enter and cause corrosion of the steel ring. The water may also result in degradation of the self-lubricating coating.
	Corrective and/or preventive measures	Use grease in addition to the self-lubricating coating to prevent water entry and corrosion of the steel placeholder ring. Use more corrosion resistant steel for the placeholder ring.
	SR / SB ?	
	Classification	Wrong materials selection

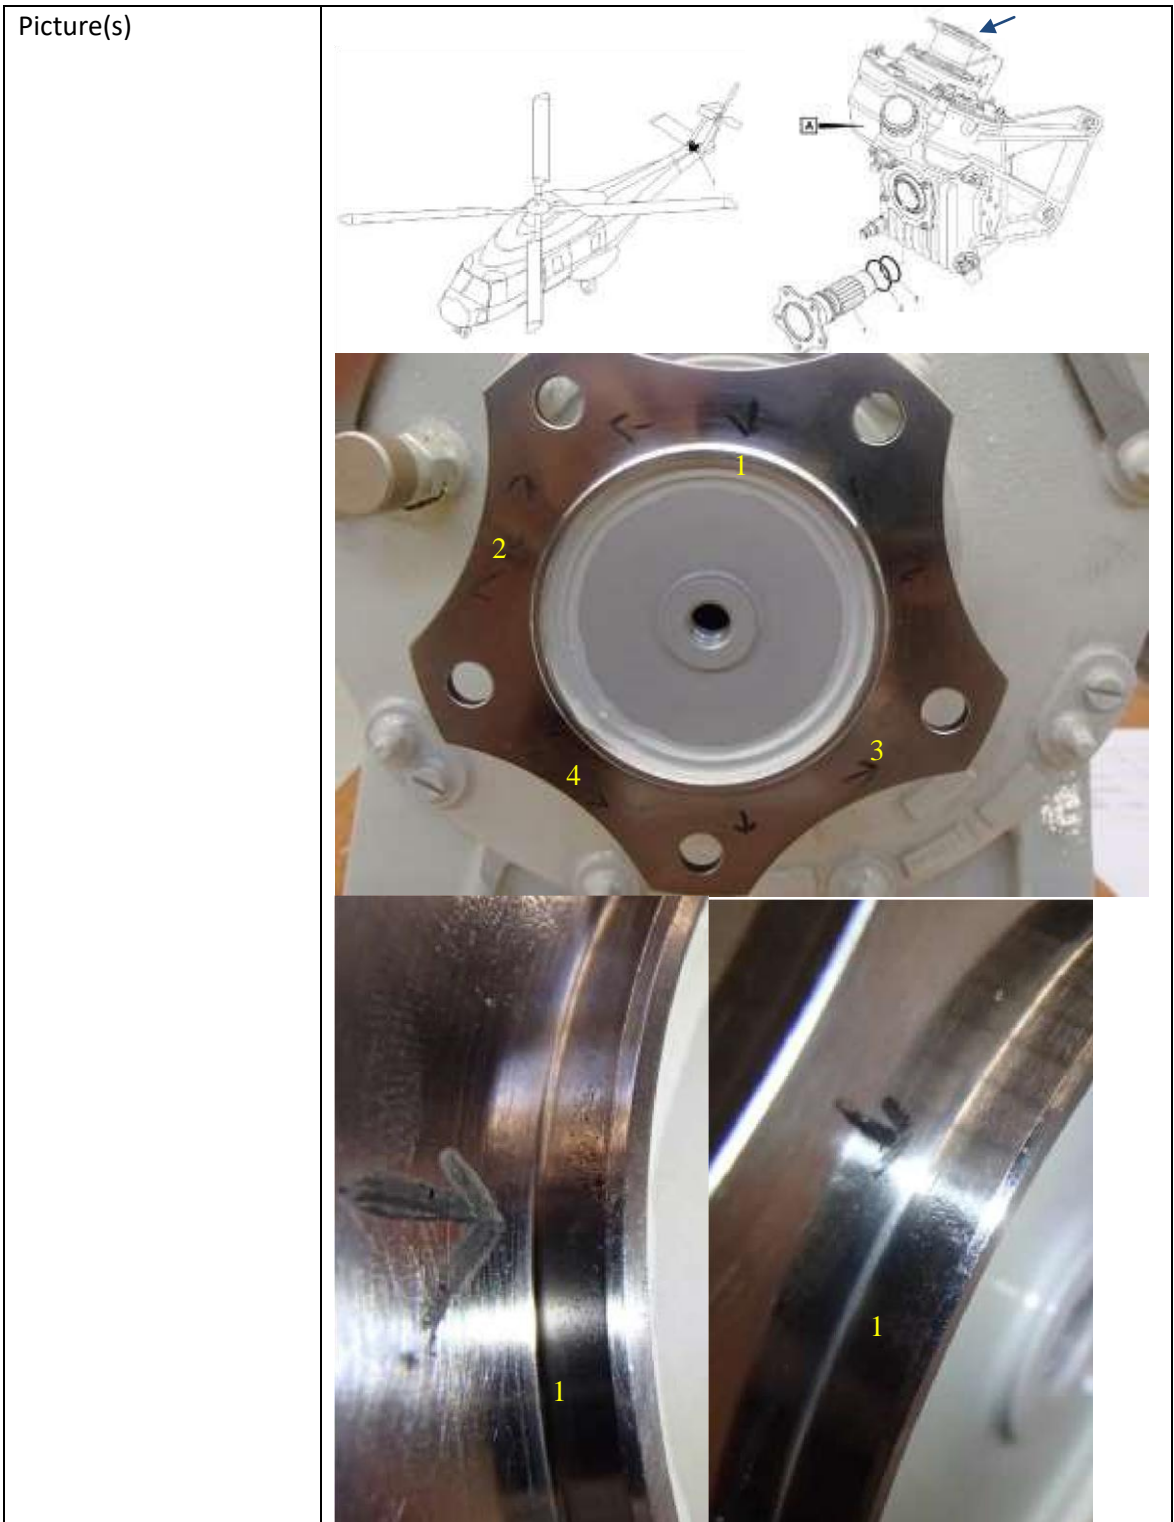
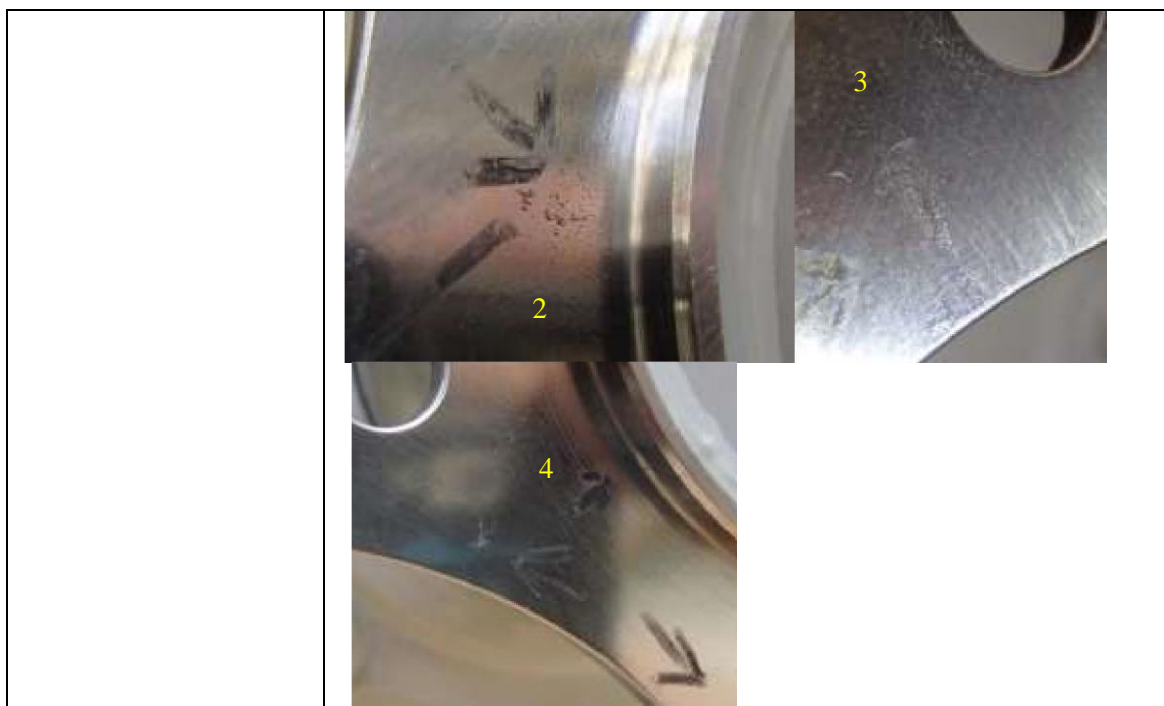
Corroding component	Intermediate tail gearbox output flange	
Component coupled to	Aluminium coupled to steel	
Preliminary analysis	Failure cause	Small movements of one flange with respect to the other caused breakdown of the protective oxide layer of the stainless steel flanges. The presence of water between the flanges caused corrosion when the protective oxide layer was damaged. The presence of corrosion products assisted in the fretting damage of the stainless steel flange.
	Corrective and/or preventive measures	Apply a grease or sealant between the two flanges to prevent fretting and corrosion.
	SR / SB ?	M5 number 10160851
	Classification	Insufficient corrosion protection

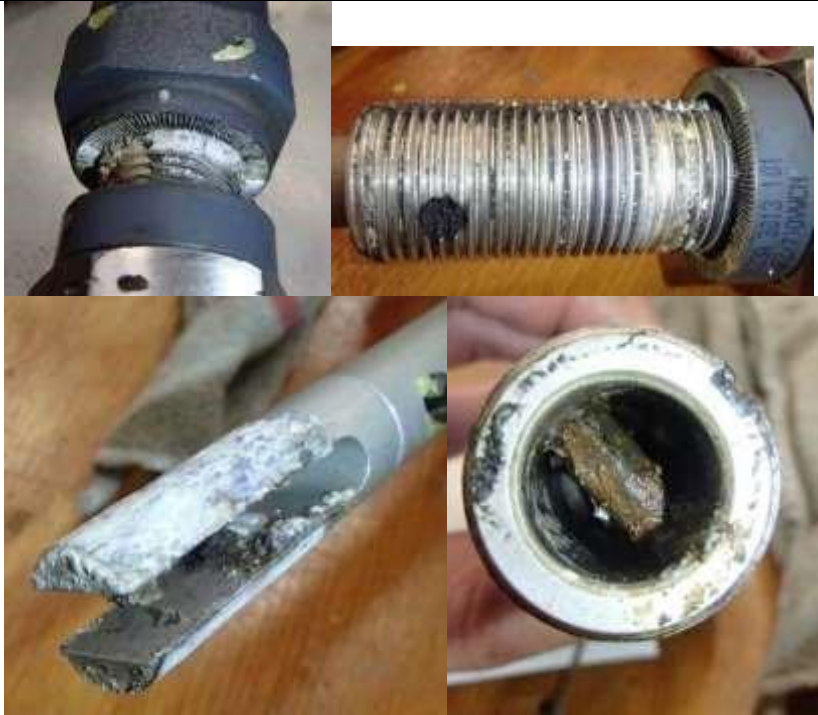
Corroding component	The inside of the pitch rods	
Component coupled to	Internal galvanic coupling of several materials, amongst which aluminium and steel	
Preliminary analysis	Corrosion cause	Water entered the internal of the pitch rod via the bleeding hole and caused corrosion of the anodised aluminium fork and the steel bar. Only the fixed (yellow) rod is not corroded because the sleeve prevented water entry. On the N233 only the steel bolts in the fork of the pitch rod are corroded
	Corrective and/or preventive measures	Cover the threaded part of the pitch rods with a sleeve or with sealant to prevent water entry. This is issued already as a solution by the industry.
	SR / SB ?	SR 1-10985303 SB JA-A-62-33-00-02A-A-A-001: sealing of the pitch rod to prevent water ingress
	Classification	Wrong design
Tail number	N227, N233

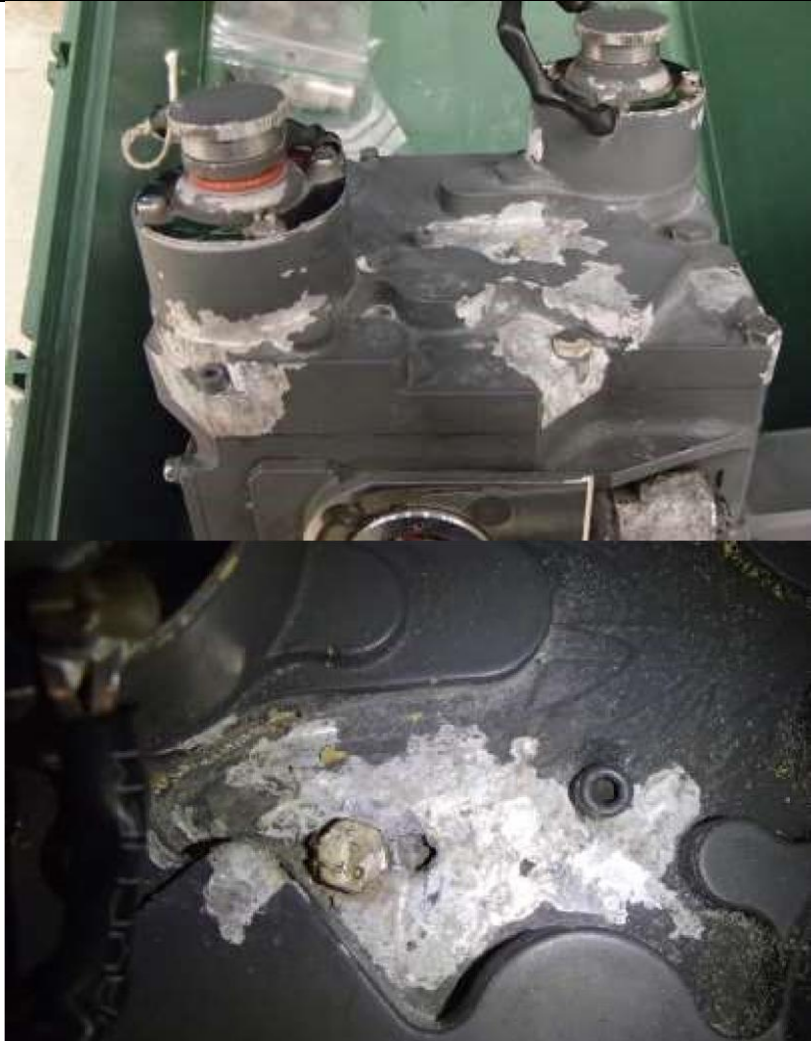
Corroding component	Corrosion on aluminium main rotor blade folding actuator (MRBFA)
Component coupled to	Fasteners (steel, titanium)
Failure cause	<p>If the coating is damaged near the fasteners galvanic corrosion of the aluminium MRBFA housing can start. Galvanic coupling of the housing to the steel and/or titanium fasteners leads to accelerated corrosion.</p> <p>The paint may be damaged by erosion as well as by tooling.</p>

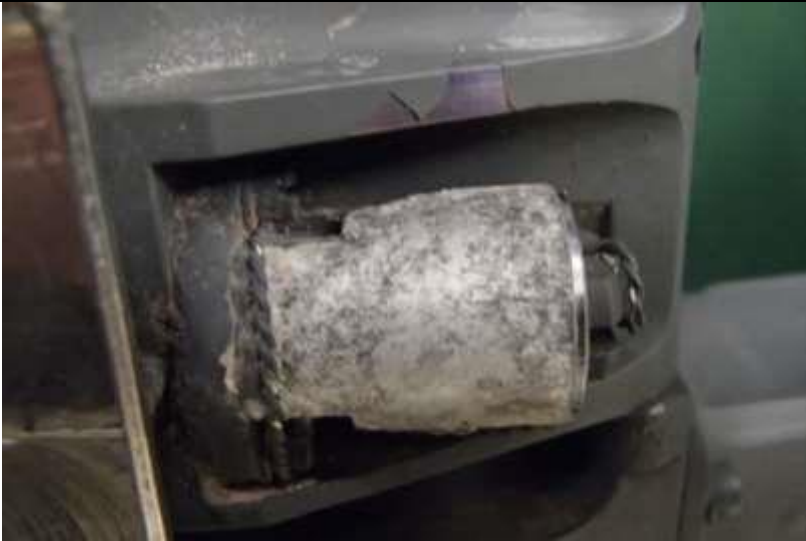
Corroding component	Corrosion on the safety mass housing of the MRBFA	
Component coupled to	steel	
Preliminary analysis	Failure cause	If the coating is damaged near the fasteners galvanic corrosion of the aluminium safety mass housing of the MRBFA can start. Galvanic coupling of the housing to the steel and/or titanium fasteners leads to accelerated corrosion. Corrosion is much less on the N233 than on the N227 due to application of grease to many of the components.
	Corrective and/or preventive measures	Apply barrier seal before painting to reduce the risk of corrosion when the paint is damaged. Apply grease or a soft film CPC on the safety mass as additional corrosion protection.
	SR / SB ?	
	Classification	Insufficient corrosion protection

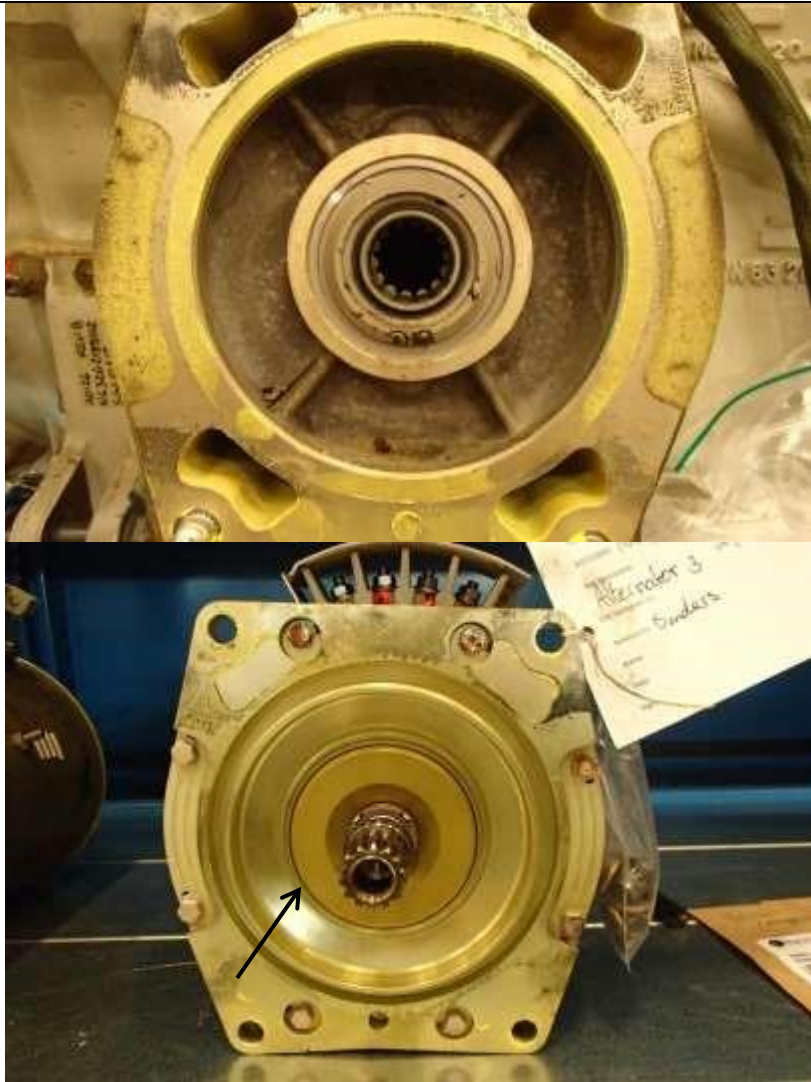
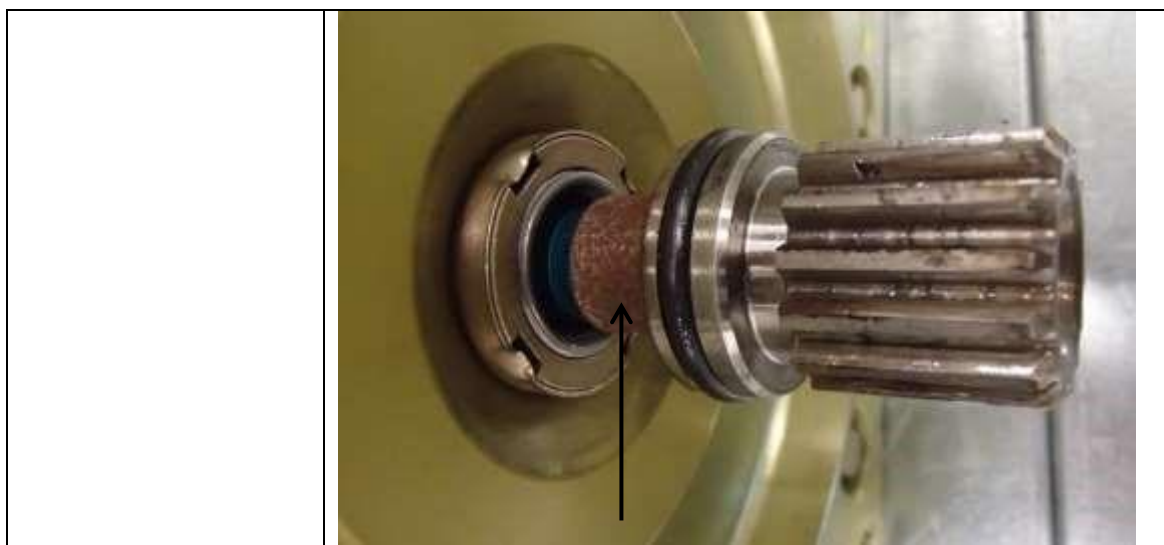
Corroding component	Corrosion of FWD alternator	
Component coupled to	Steel coupled to stainless steel	
Preliminary analysis	Failure cause	Water ingress that should not have occurred caused corrosion of the steel component (lower picture). Water entry occurred most probably through a grid on the back of the alternator and enters the area between the surfaces indicated in the middle image.
	Corrective and/or preventive measures	Prevent water ingress by using better sealing, or by covering the grid from direct water spray.
	SR / SB ?	
	Classification	Wrong design

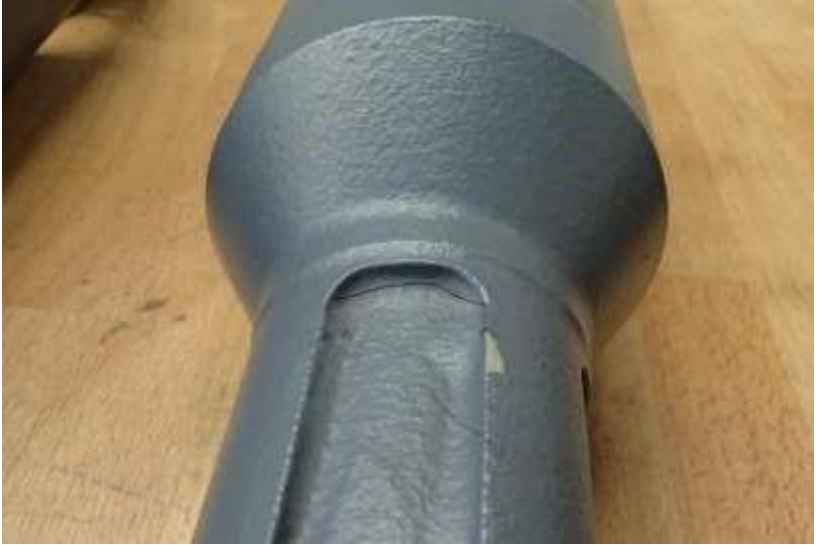
Corroding component		Main gearbox support strut (suspension bar)
Component coupled to		Not applicable
Preliminary analysis	Failure cause	Paint is hard and inflexible, which leads to cracking and chipping of the paint. Corrosion has not started yet.
	Corrective and/or preventive measures	Select paint with higher flexibility and better adhesion. Apply a thinner paint film, because thinner paint films have better flexibility than thicker paint films.
	SR / SB ?	
	Classification	Wrong materials selection

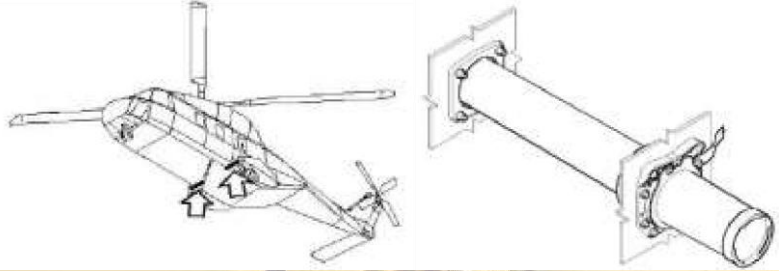
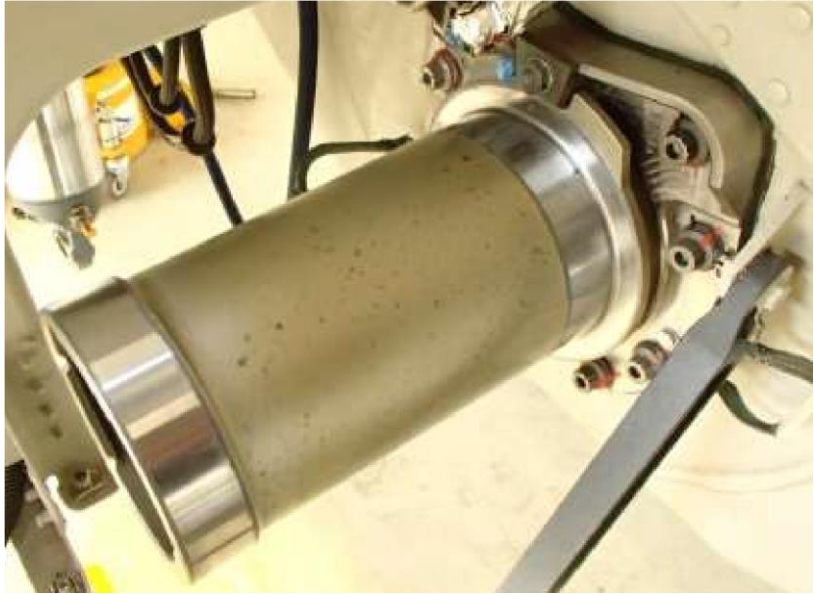
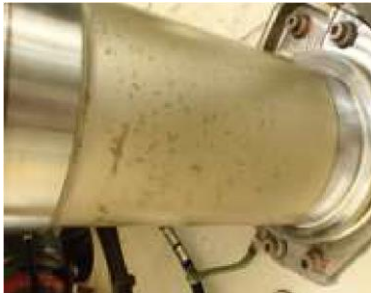
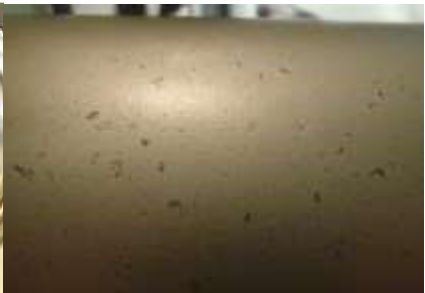
Corroding component		Landing gear pintle axle (anodised aluminium)
Component coupled to		Hard chrome tread for landing gear trailing arm, steel coupling plate and CFRP fuselage
Preliminary analysis	Failure cause	<p>Salt water sprays onto the pintle axle and causes degradation of the anodic layer followed by pitting corrosion of the aluminium. The area that is shielded from salt water spray by the trailing arm shows no pitting corrosion.</p> <p>Static electricity may have accelerated the corrosion. The bonding lead connecting the pintle axle to the helicopter shows light</p>

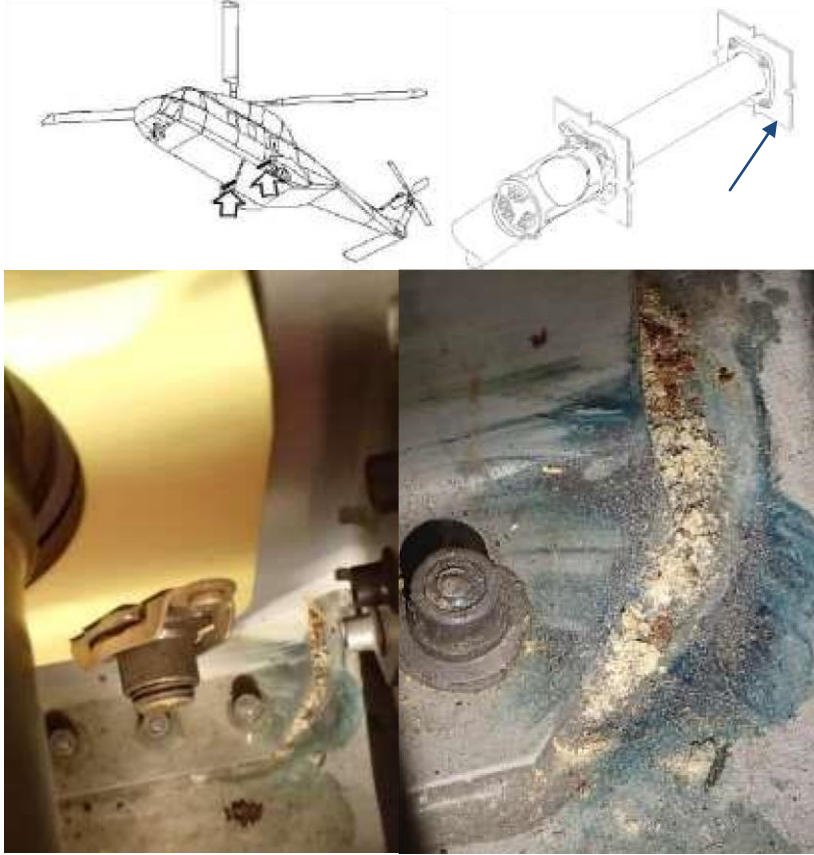
Corroding component		Main landing gear inner rib (RH)
Component coupled to		CFRP, titanium
Preliminary analysis	Failure cause	Water could enter the right hand shell of the subfloor through the gaps between the floor panels, because the floor panels were not sealed. Stagnant water caused corrosion of the bracket. It should be noted that the titanium installation bolts of the pintle axle are not sealed, although sealing is prescribed in the install procedure. Only very light corrosion is seen on the bolts.
	Corrective and/or preventive measures	Sealing of the floor panels to prevent water entry. Spray application of a hard film CPC to prevent corrosion in the case water enters the area even though the floor panels are sealed. Sealing of the titanium bolts.
	SR / SB ?	
	Classification	Wrong design Wrong manufacturing

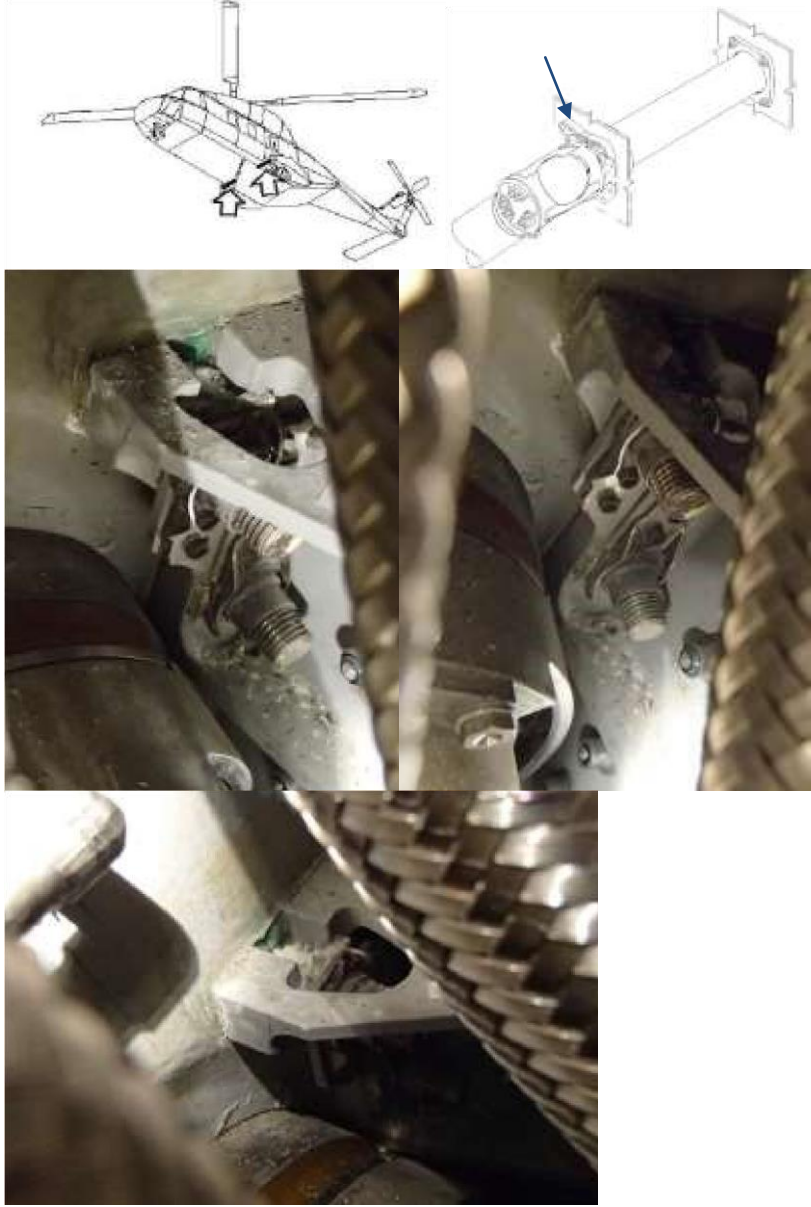
Corroding component	Main landing gear outer bracket (RH)	
Component coupled to	CFRP	
Preliminary analysis	Failure cause	Water could enter most probably through the opening in the frame at the position of the pressure refuel valve actuator and cause corrosion of the main landing gear outer bracket.
	Corrective and/or preventive measures	Close the opening at the position of the pressure refuel valve actuator with a transparent window. Apply a CPC to the inside of the door post.
	SR / SB ?	
	Classification	Insufficient corrosion protection

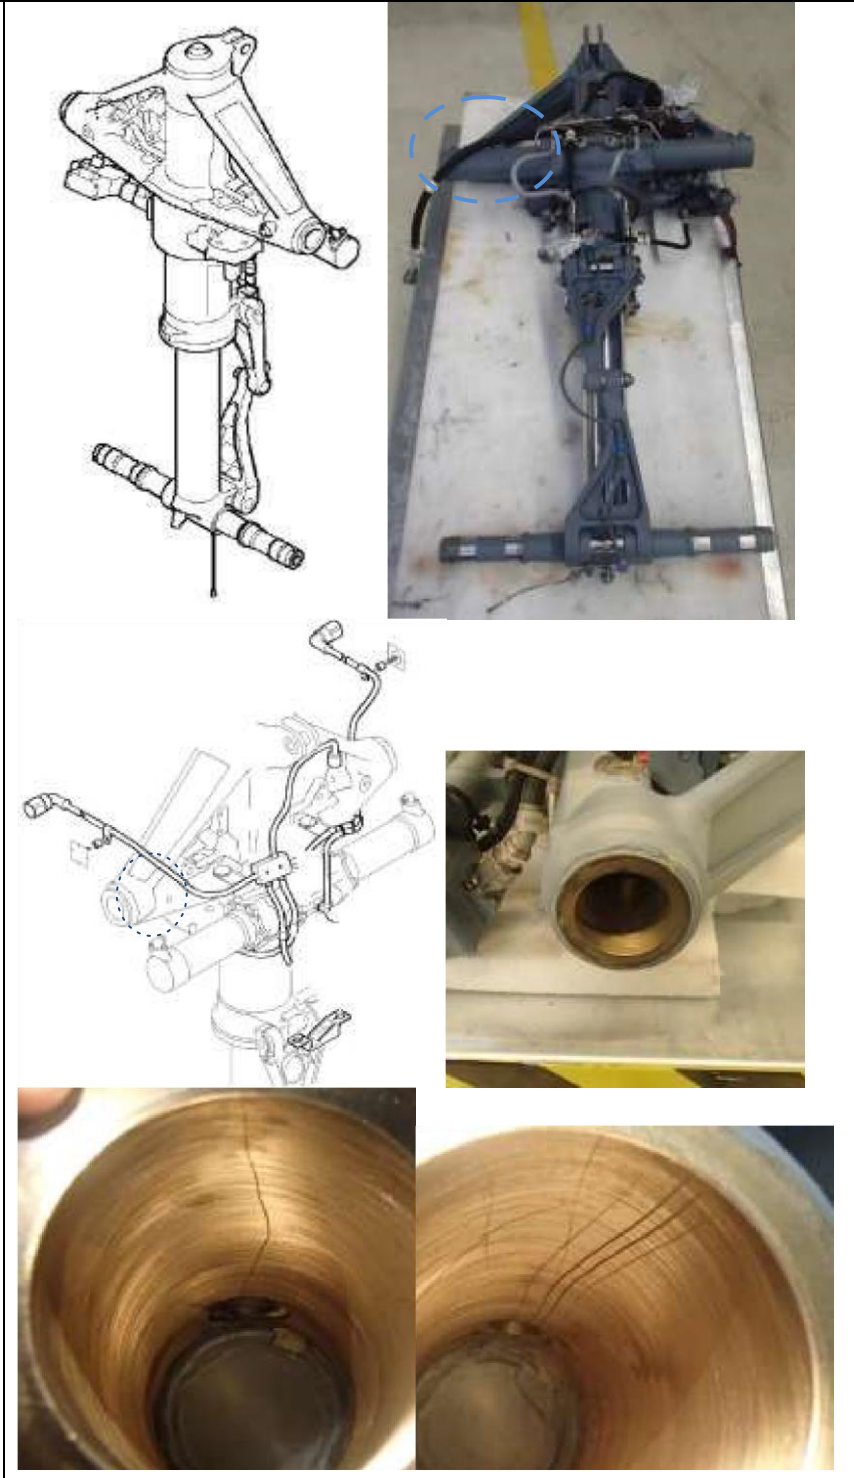
<p>Corroding component</p>	<p>NLG shockstrut – NFH</p>
<p>Component coupled to</p>	<p>Not applicable</p>
<p>Failure cause</p>	<p>Hard particles were drawn into the tube and caused scratches along the inside of the tube. This happened when disassembling the landing gear.</p>

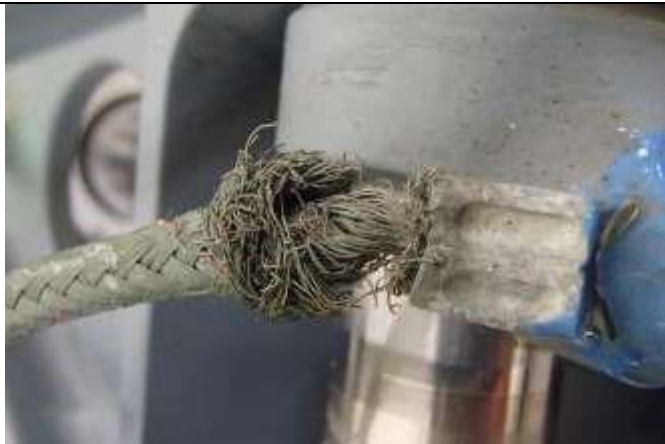
Corroding component		NLG locking mechanism
Component coupled to		CFRP
Preliminary analysis	Failure cause	Corrosion of the bonding lead and fracture of the wires in the braid upon bending after they have become brittle by severe corrosion.
	Corrective and/or preventive measures	Periodic inspection of the bonding leads for corrosion and replacement if corrosion is severe. Additionally they may be protected against corrosion by a sleeve or rubber tubing, but then sealing of the end of the tubing must be done to prevent water entry. Application of a soft film CPC may also reduce corrosion.
	SR / SB ?	
	Classification	Insufficient corrosion protection
