COMPANY CONFIDENTIAL  
NLR-CR-2014-129

## Inventory of corrosion occurrences on two NH90 helicopters after operation in tropical and saline environment

L. 't Hoen-Velterop

Nationaal Lucht- en Ruimtevaartlaboratorium  
National Aerospace Laboratory NLR

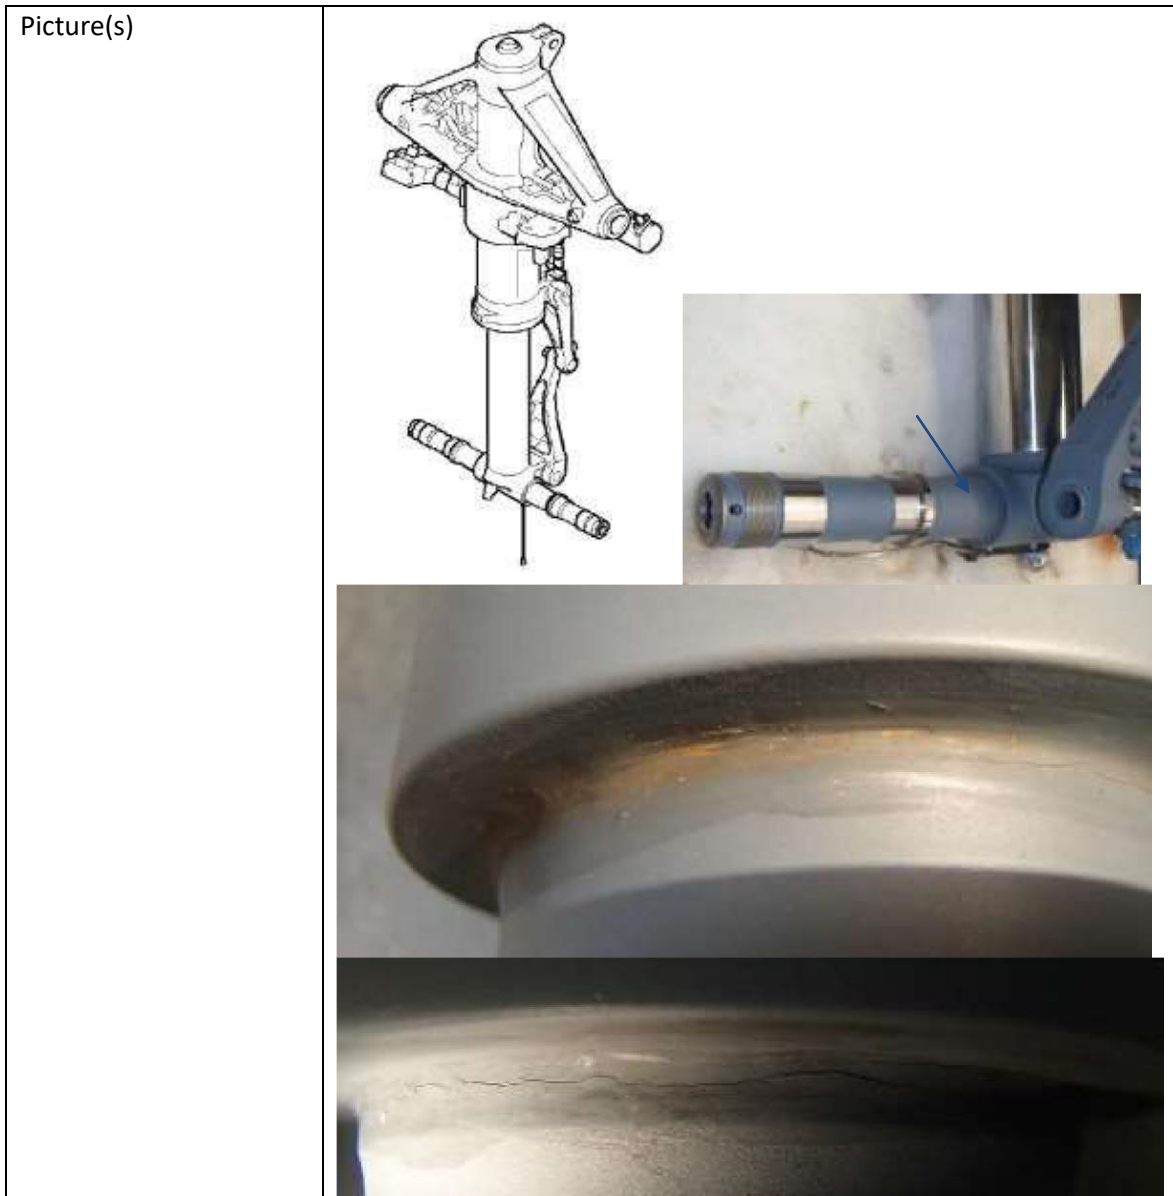
Corroding component		NLG pintle pin
Component coupled to		Not applicable
Preliminary analysis	Failure cause	Cracking of the paint allowed water to enter the pin-lug coupling of the pintle pin and caused corrosion of the steel.
	Corrective and/or preventive measures	Prevent cracking of the paint by use of more flexible paint. Use a highly flexible sealant under the paint in the radius to prevent sharp radii in the paint that are prone to cracking.
	SR / SB ?	
	Classification	Wrong materials selection

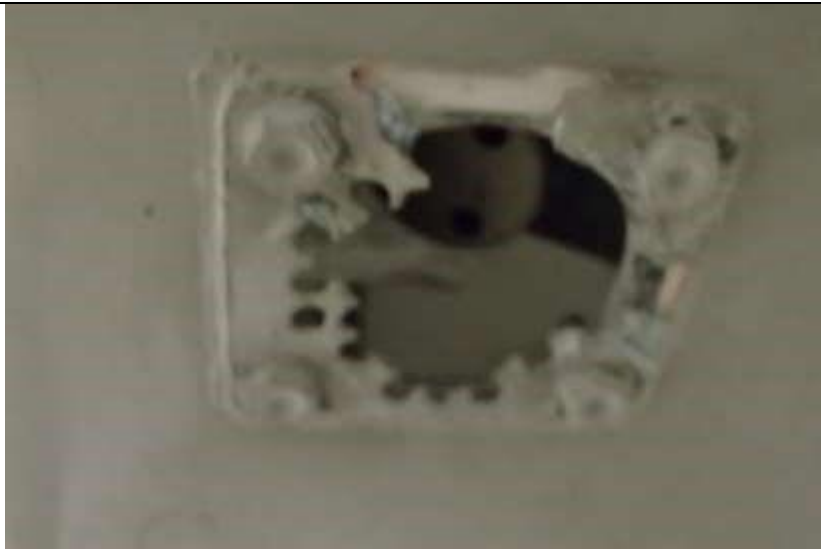
Corroding component		Right hand sponson immersion sensor cover grid
Component coupled to		CFRP cover, steel bolts
Preliminary analysis	Failure cause	The aluminium grid is most probably painted at the outside only. Water can spray through the grid and salt deposits can form on the inside. Salt water on the inside leads to corrosion that is accelerated by galvanic coupling of the aluminium grid to the CFRP cover.
	Corrective and/or preventive measures	Paint the grid on both sides before installing it on the cover. This ensures electrical insulation of the aluminium from the more noble CFRP cover and steel bolts and also prevents corrosion of the grid on the top surface when salt water entered through the grid. Use another material for the grid, like CFRP, plastic, glass fibre reinforced plastic.
	SR / SB ?	
	Classification	Wrong materials selection
Tail number		N227, N233

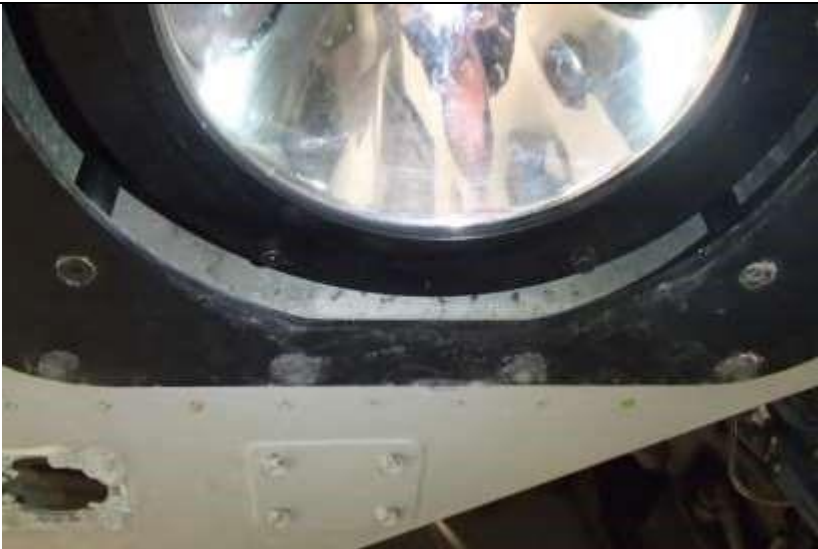
Corroding component	Search light assembly
Component coupled to	Several materials are coupled to each other
Preliminary analysis Failure cause	Several components start corroding after contact with salt water. The components are not electrically insulated from each other and not protected from the salt water. As a result corrosion can start and is accelerated by galvanic coupling.
Corrective and/or preventive measures	Apply sealant or jointing compound between the different materials. Apply paint, sealant or grease to protect the bare metal components.
SR / SB ?	
Classification	Wrong materials selection
