COMPANY CONFIDENTIAL  
NLR-CR-2014-129

## Inventory of corrosion occurrences on two NH90 helicopters after operation in tropical and saline environment

L. 't Hoen-Velterop

Nationaal Lucht- en Ruimtevaartlaboratorium  
National Aerospace Laboratory NLR

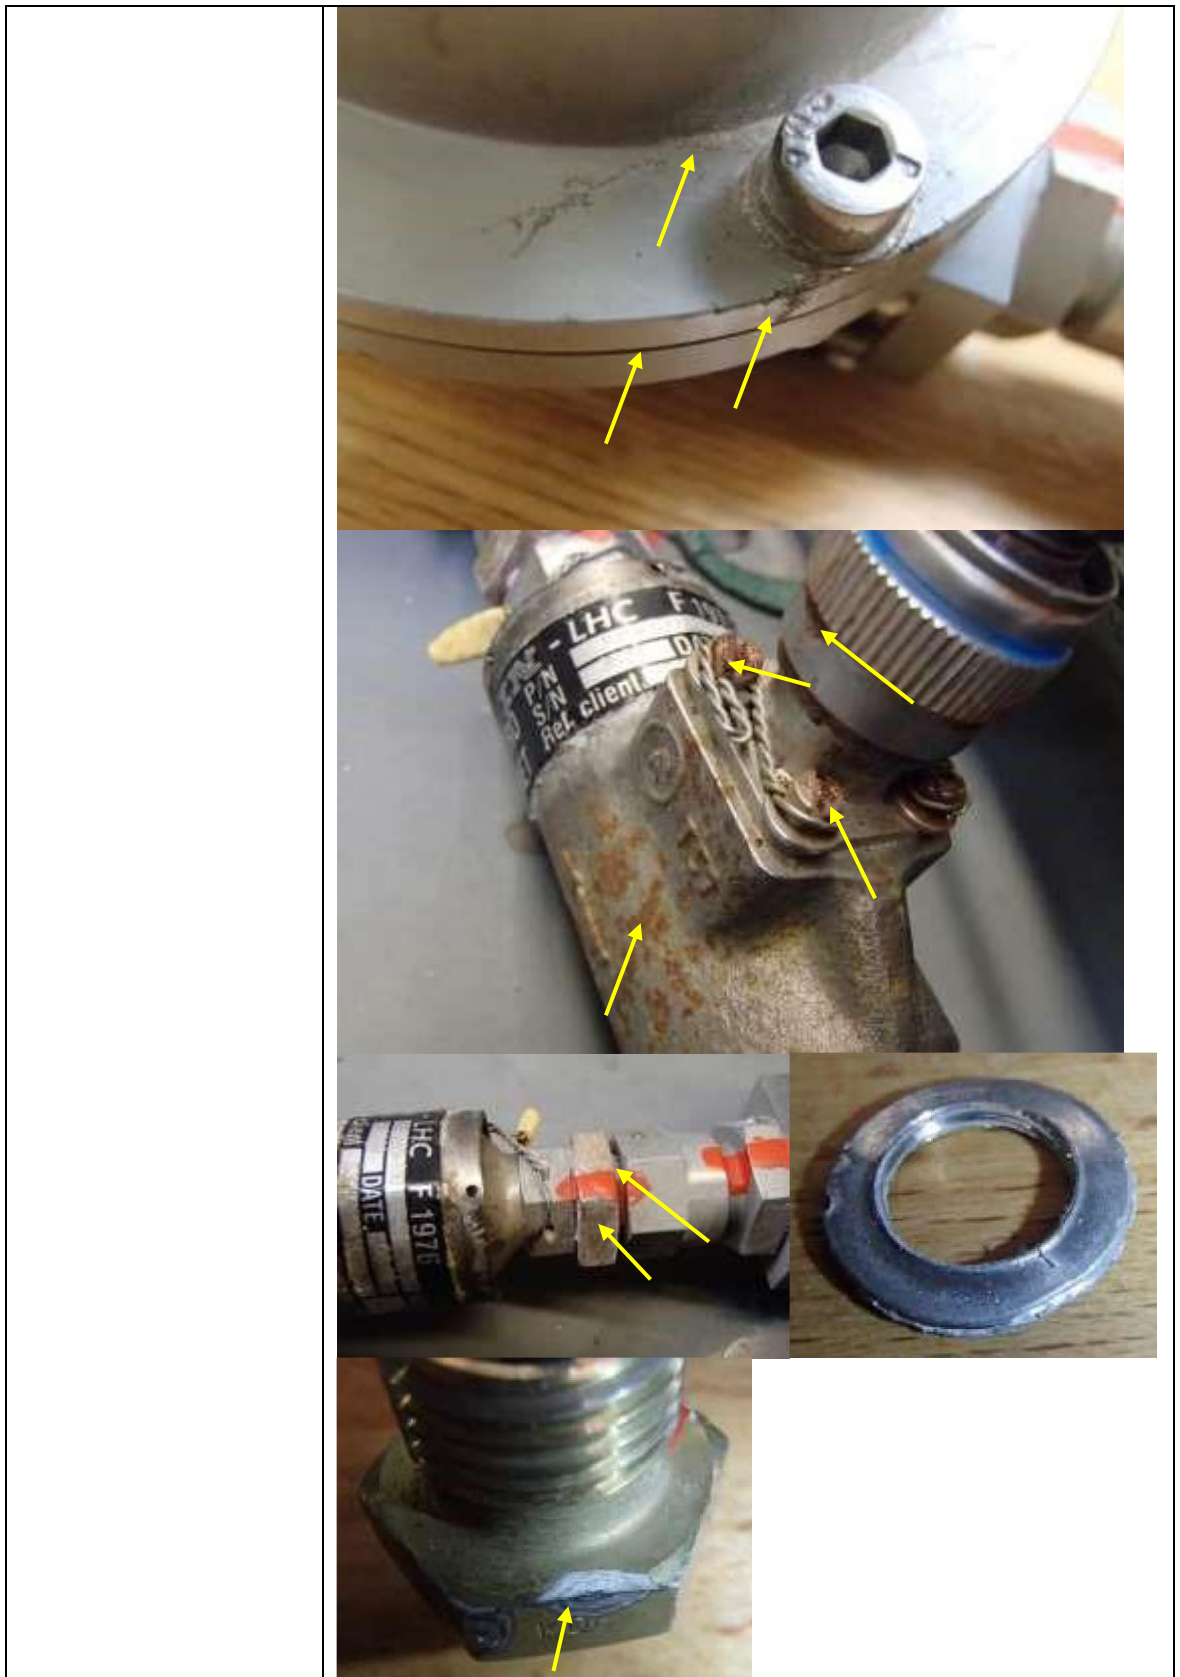
Tail number	N227, N233
ATA nr	30-81
NCage code	Pressure reducing valve: 2416AC020101:F1958 Solenoid valve: 3089-100:F1976
Picture(s)

Corroding component		Pressure reducing valve and solenoid valve
Component coupled to		CFRP structure
Preliminary analysis	Failure cause	<p>The pressure reducing valve shows corrosion at the location of the fasteners and in the crevice between the mating surfaces. The fasteners may have damaged the paint on the aluminium housing. Galvanic coupling accelerated the corrosion.</p> <p>Water could enter the crevice between the two parts and caused accelerated crevice corrosion.</p> <p>The solenoid valve is corroded on the inside, at the couplings. The (cadmium) coating shows poor adhesion at a few locations. Salt air passed through the valve and caused corrosion.</p> <p>Many components of the solenoid valve show corrosion. Coupling to the CFRP structure of the upper deck and to more noble metallic parts accelerated the corrosion that was initiated by the salt air that could enter the upper deck.</p>

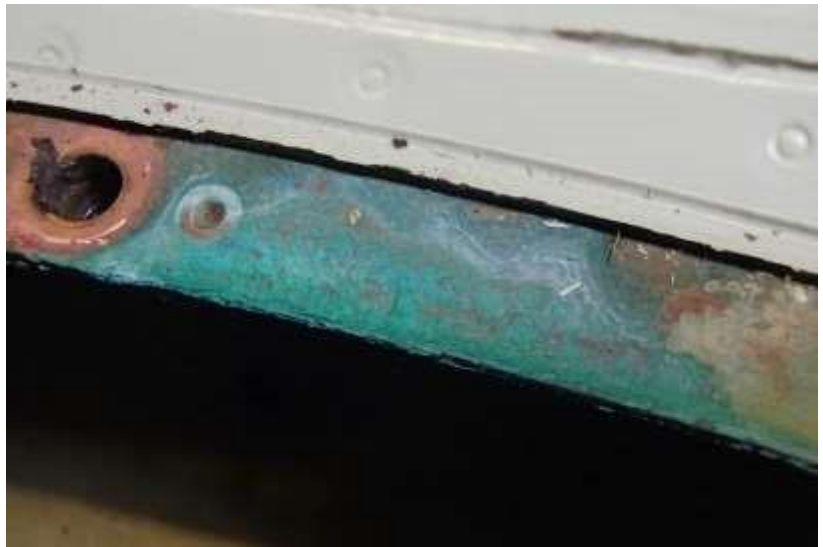
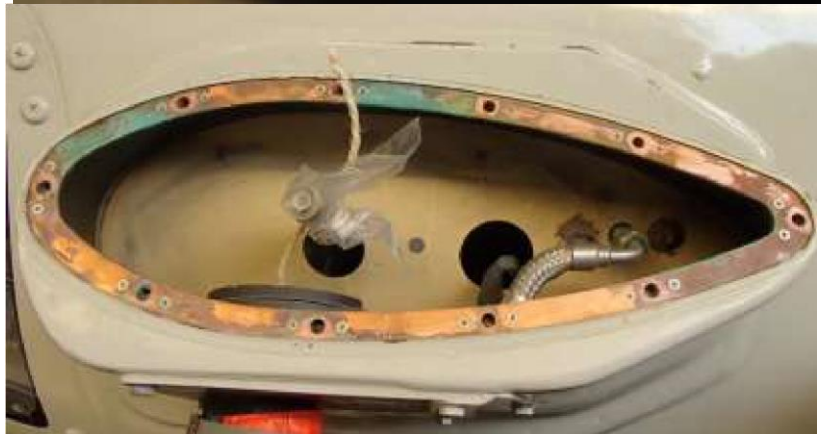
Corroding component	Copper antenna bonding strip	
Component coupled to	CFRP intermediate structure	
Preliminary analysis	Failure cause	Water ingress along joint led to galvanic corrosion of copper bonding strips coupled to CFRP fuselage.
	Corrective and/or preventive measures	Replace copper strip. Use sealant (self-levelling green) to prevent water ingress along fasteners and along the lap joint of the antenna connection Check sealant integrity (presence of cracks in the paint) on a regular basis, especially in hot climates. Apply a soft film CPC to prevent moisture ingress if the sealant is cracked
	SR / SB ?	
	Classification	Insufficient corrosion protection
Tail number	N227	
ATA nr	43-31	
NCage code	S433M1050101:C0418 S433M1050102:C0418	
Picture(s)	Not available

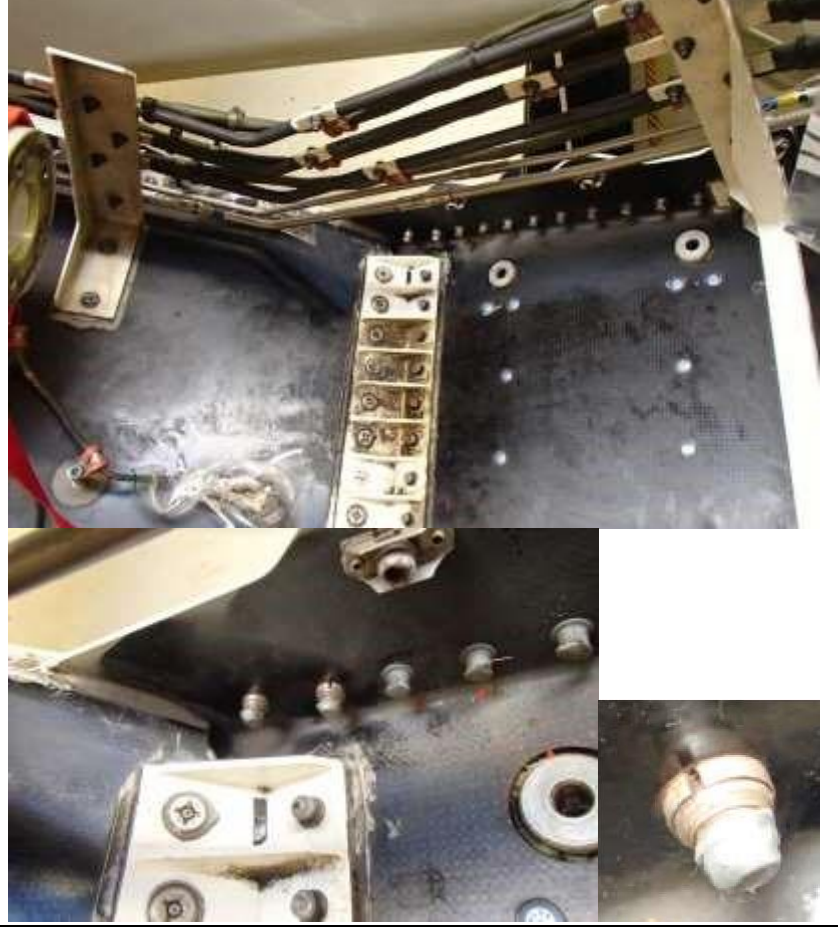
<p>Corroding component</p>	<p>Fasteners in tail pylon</p>
<p>Component coupled to</p>	<p>CFRP tail structure</p>

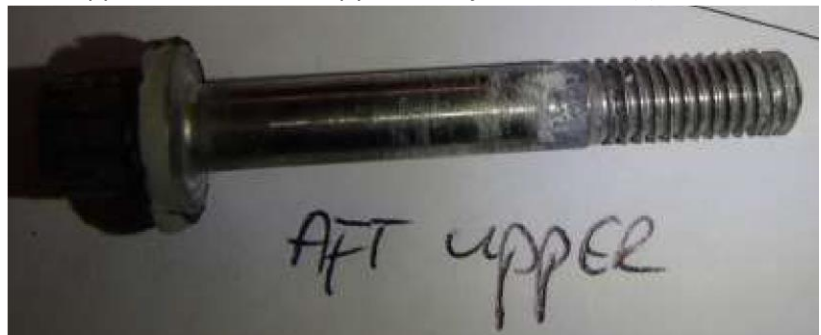
FWD upper attachment tail pylon with jammed bolt (r)

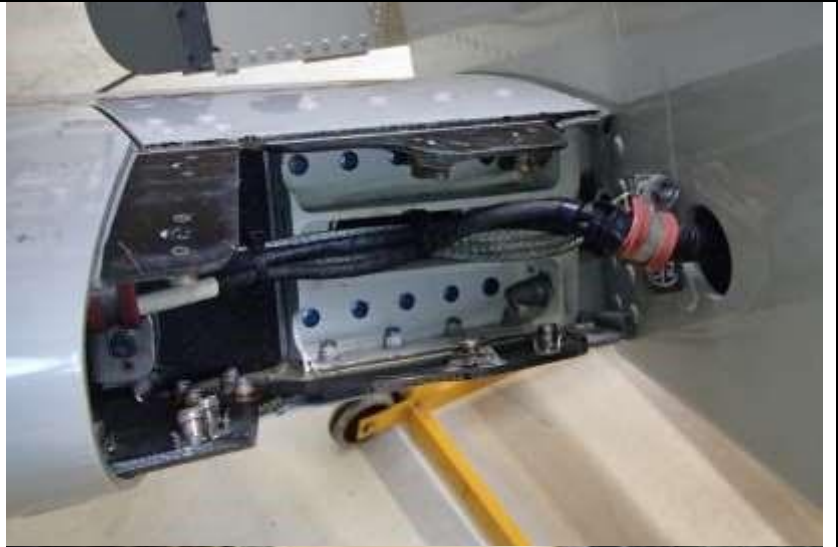
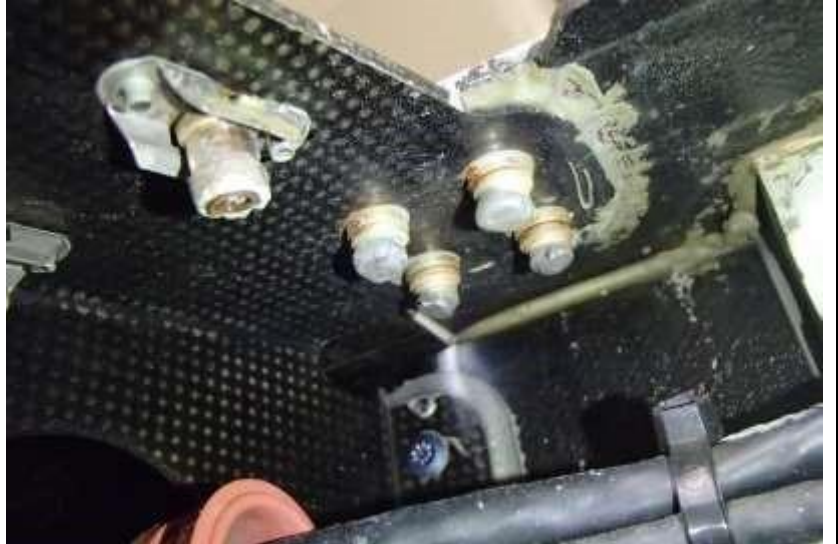
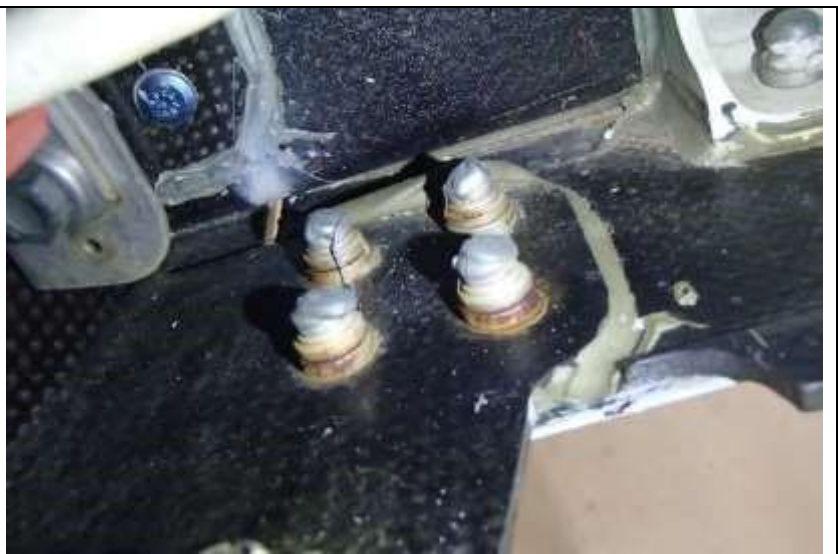
Tail number	N227
ATA nr	55-11
NCage code	S551F1102053:H1822

Corroding component		Fasteners in the horizontal stabilizer
Component coupled to		CFRP horizontal stabilizer
Preliminary analysis	Failure cause	Moisture ingress into the horizontal stabilizer resulted in galvanic corrosion of the least noble parts of the fasteners. The washers are cracked most probably due to overload by stresses induced by corrosion products. The socket head of the fasteners is sealed to prevent water collection and subsequent corrosion.
	Corrective and/or preventive measures	Sealing of the whole fasteners to prevent corrosion, instead of sealing of the fastener top only. Wet installation of the fasteners. Application of jointing compound between the washer of the fasteners and the CFRP skin.
	SR / SB ?	Replace broken fasteners with oversized fasteners or use bushings to accommodate the possibly increased hole size. Install the fasteners wet and seal the whole fastener instead of the top only. Replace horizontal stabilizer if corrosion is severe. Apply a hard film CPC on the inside of the new horizontal stabilizer.

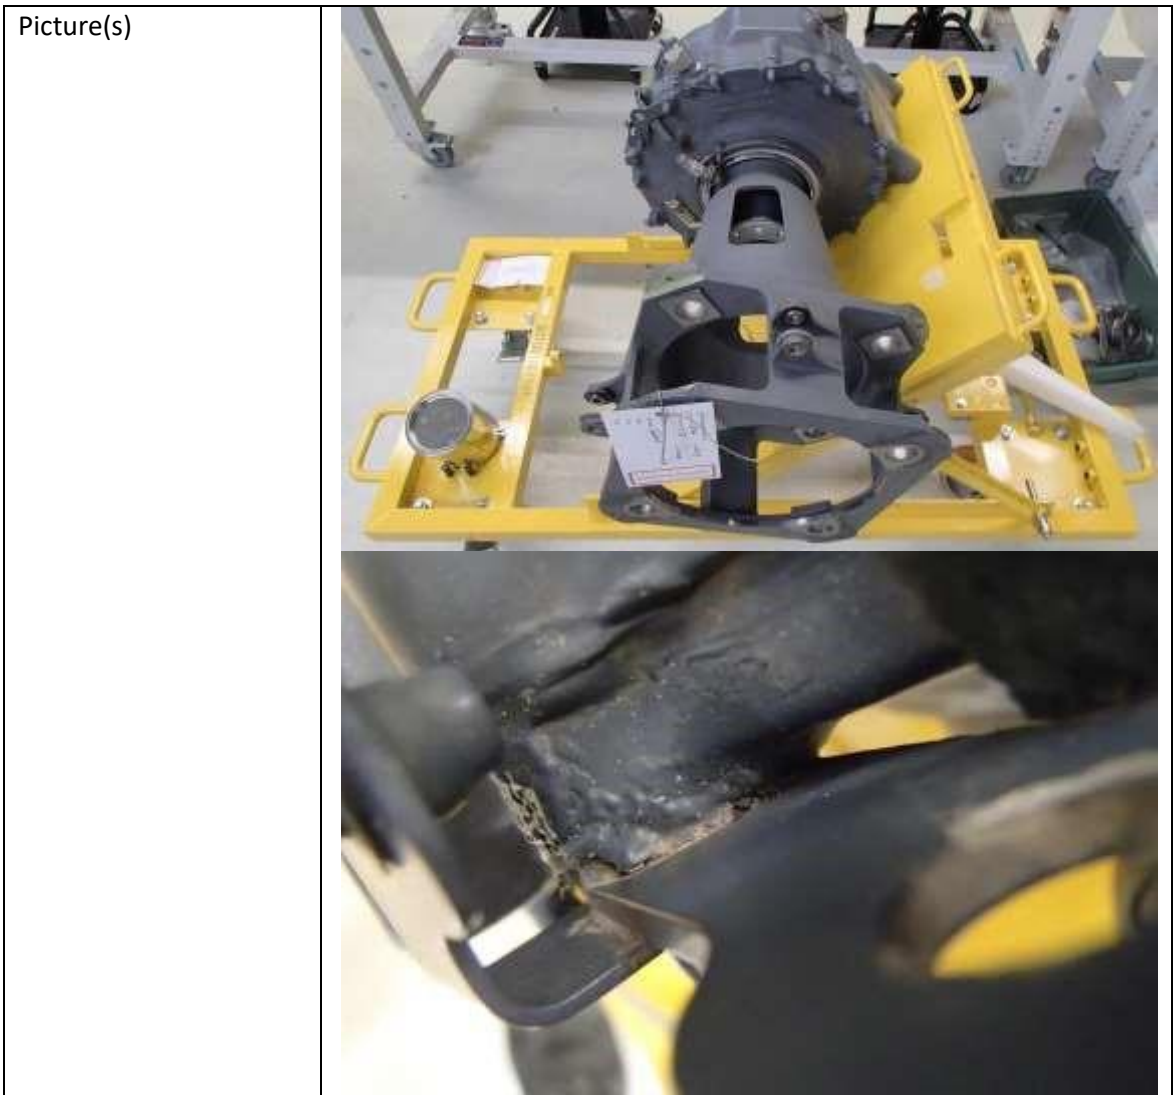
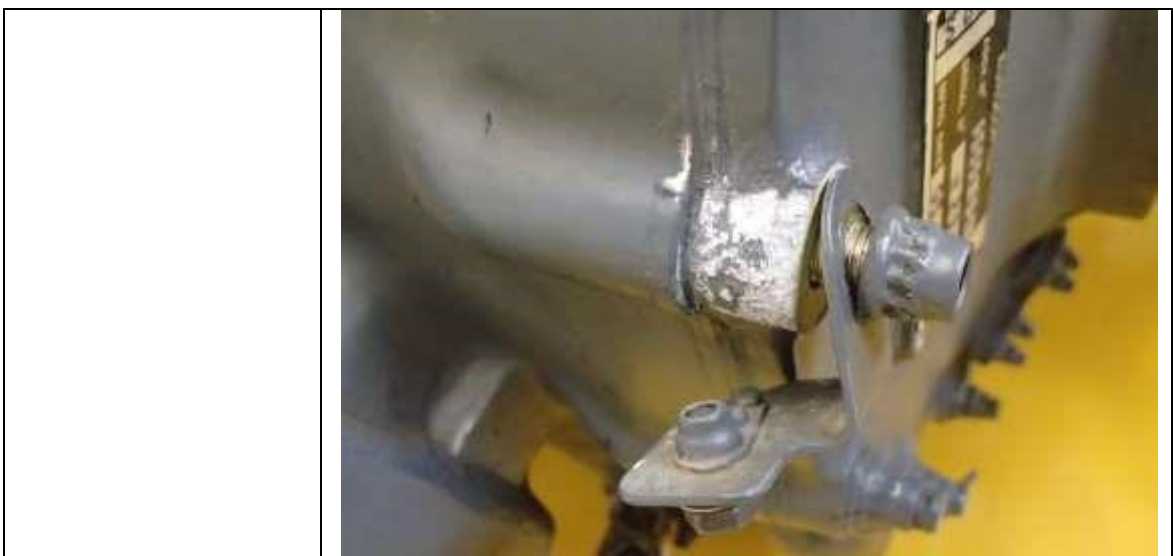
Tail number	N227, N233
ATA nr	65-20
NCage code	S652A0000051:M0294

Corroding component	Magnesium tail gear box (TGB) housing	
Component coupled to	Steel bracket, steel and titanium fasteners and CFRP tail	
Preliminary analysis	Failure cause	Galvanic corrosion of the magnesium housing occurs as soon as the protective paint is damaged. Coupling of the magnesium gearbox to more noble metals like steel and titanium accelerates the corrosion. During blending of the corrosion it turned out that the corrosion had progressed under the coating.
	Corrective and/or preventive measures	Use jointing compound to prevent galvanic coupling, so that corrosion is less severe when the coating is damaged. Use a barrier seal under the paint to reduce the risk of paint damage.
	SR / SB ?	
	Classification	Insufficient corrosion protection

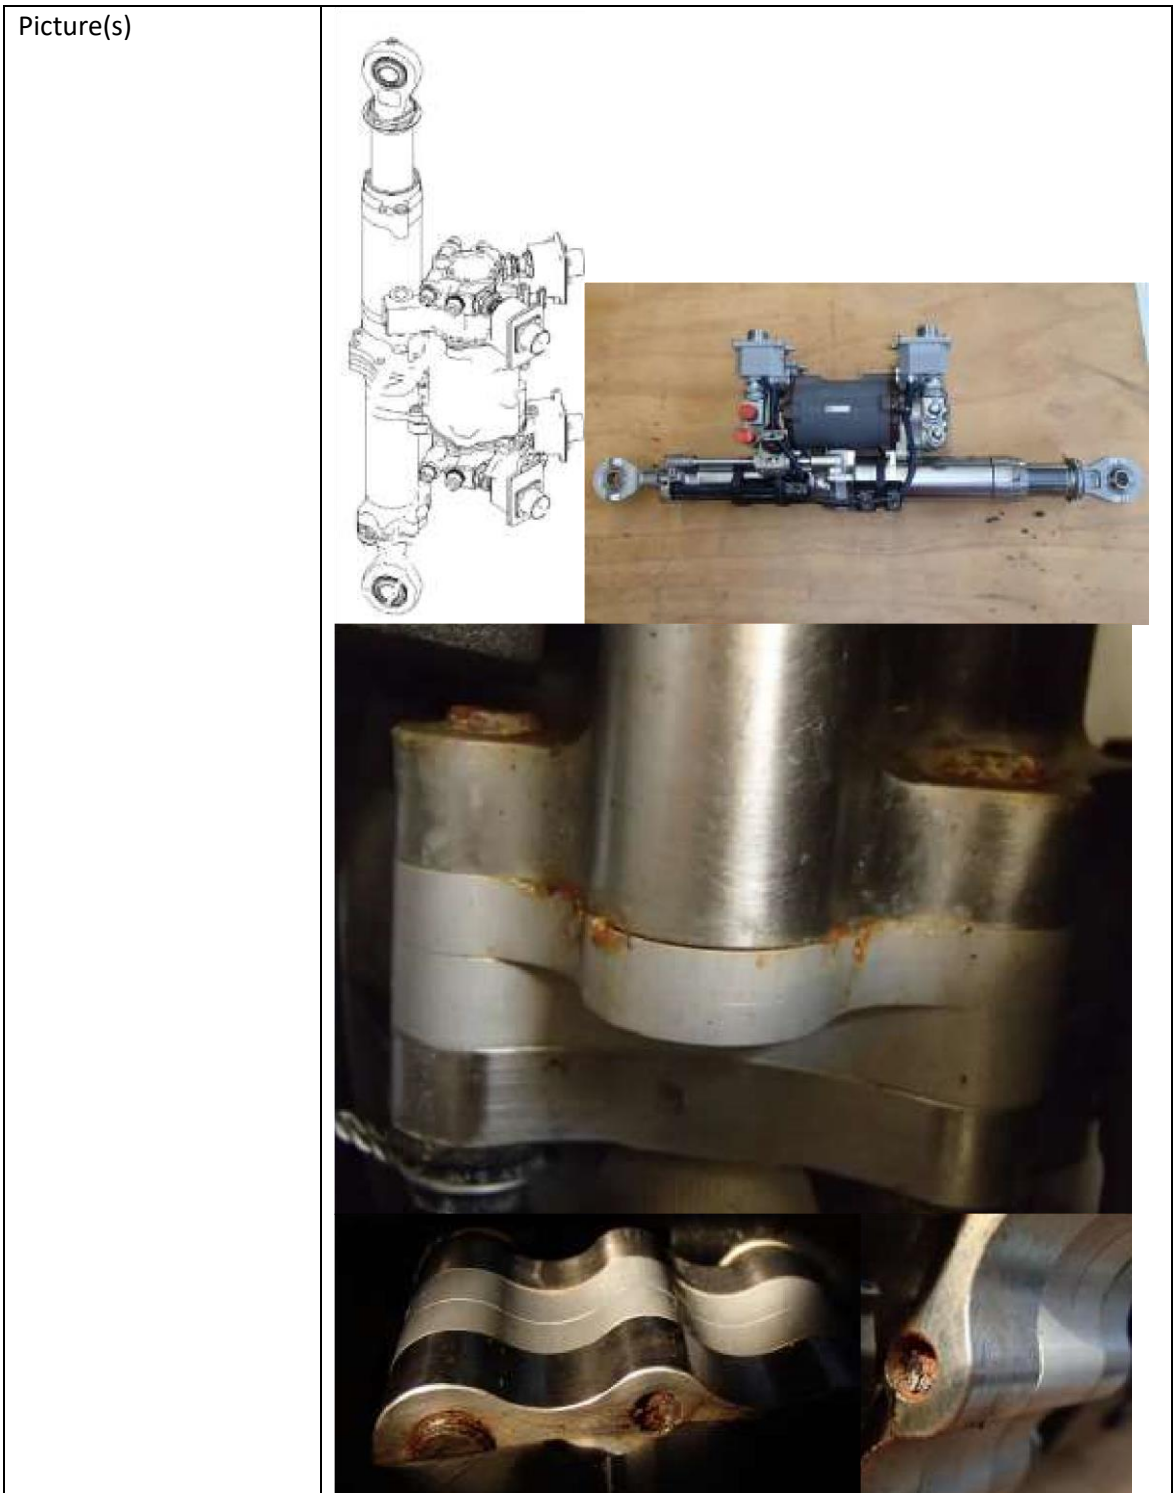
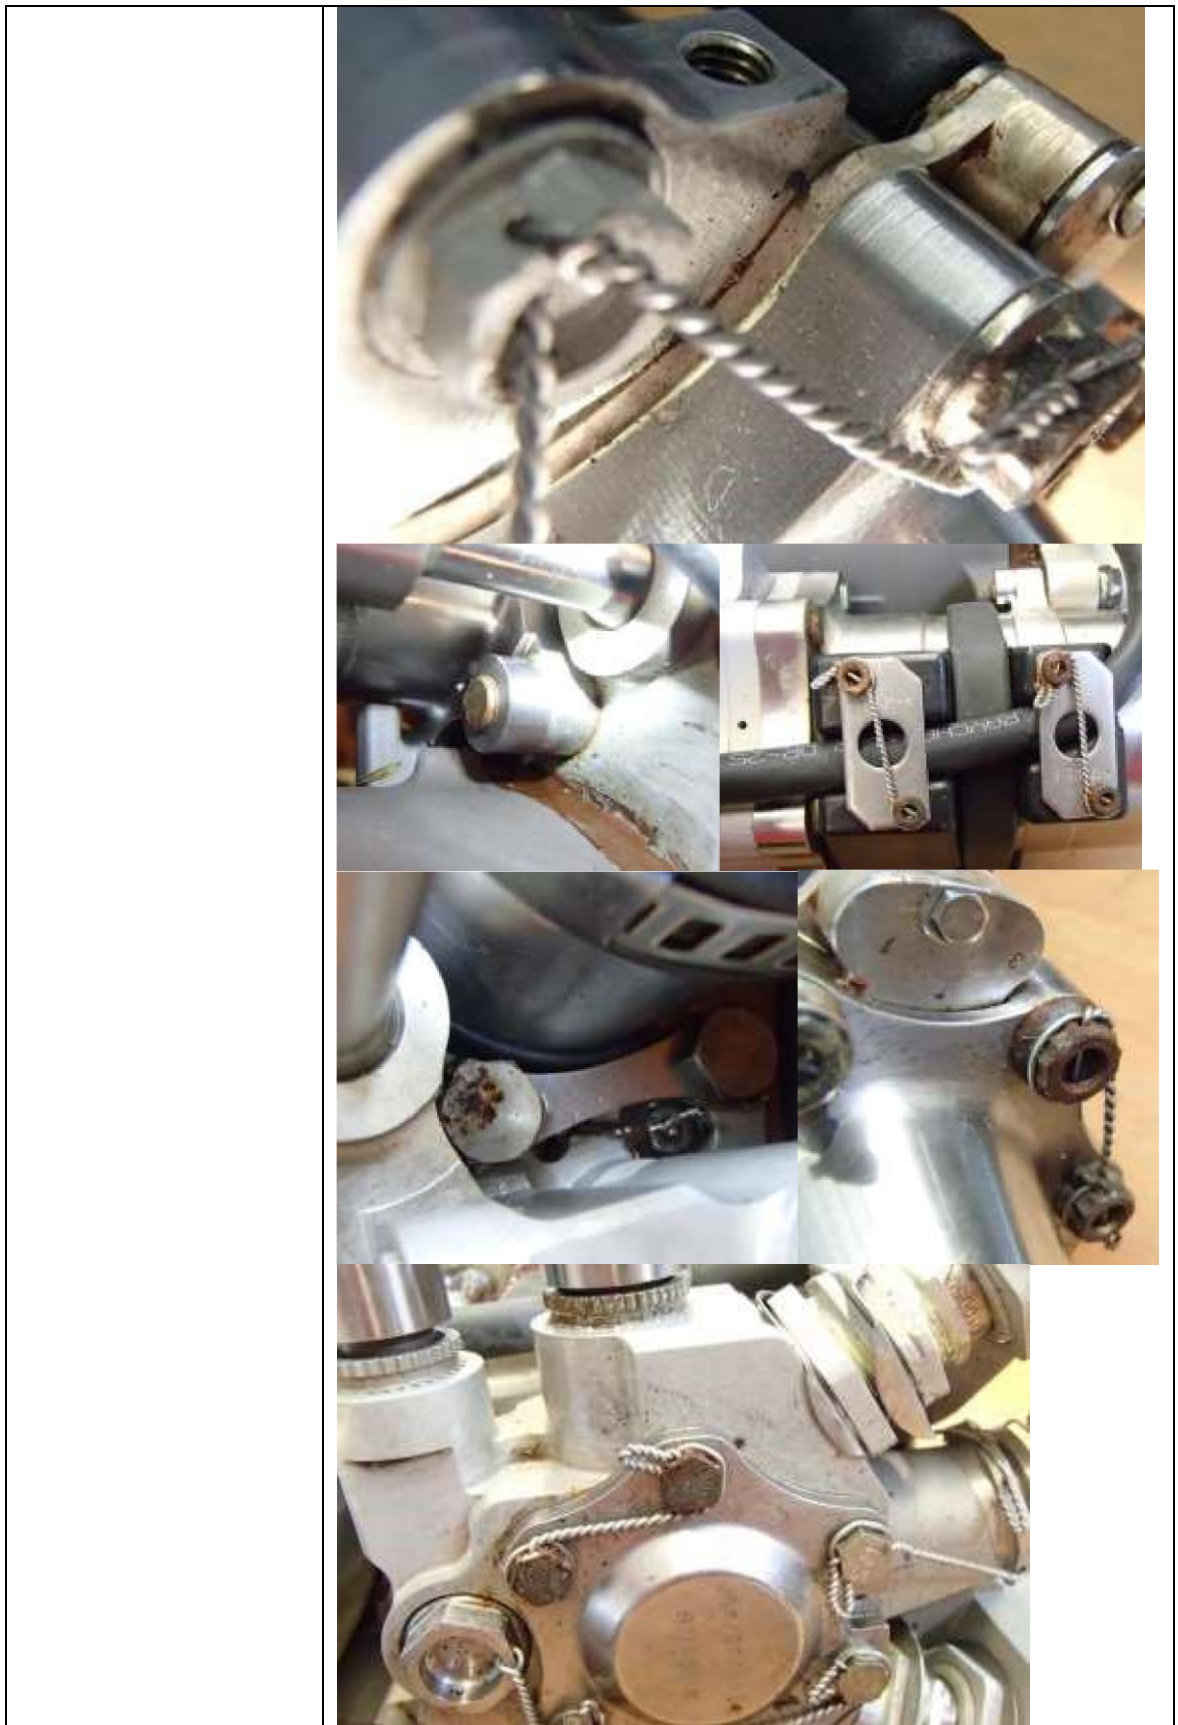
Tail number	N227
ATA nr	67-33
NCage code	S673A30A3000:F0210

Corroding component	Main rotor actuator (MRA) / main servo assembly electrical
Component coupled to		Several materials coupled (stainless steel, steel,...)	
Preliminary analysis	Failure cause	<p>The MRA is protected against high temperatures by a blanket that collects water and contains the water once collected. The water facilitates:</p> <ul style="list-style-type: none"> <li>• Crevice corrosion in crevices between mating surfaces of the actuator, causing separation of the surfaces.</li> <li>• Corrosion of most of the steel fasteners.</li> <li>• Pitting corrosion of stainless steel components</li> </ul>	
	Corrective and/or preventive measures	<p>Apply jointing compound on faying surfaces to prevent galvanic and crevice corrosion.</p> <p>Apply sealant or grease to the steel fasteners.</p> <p>Use a fire blanket that does not contain water if water spray is allowed to enter.</p> <p>Apply a hard film CPC to the stainless steel components to prevent pitting corrosion in salt water environment.</p> <p>Select a stainless steel with better resistance to pitting corrosion in salt water environment.</p>

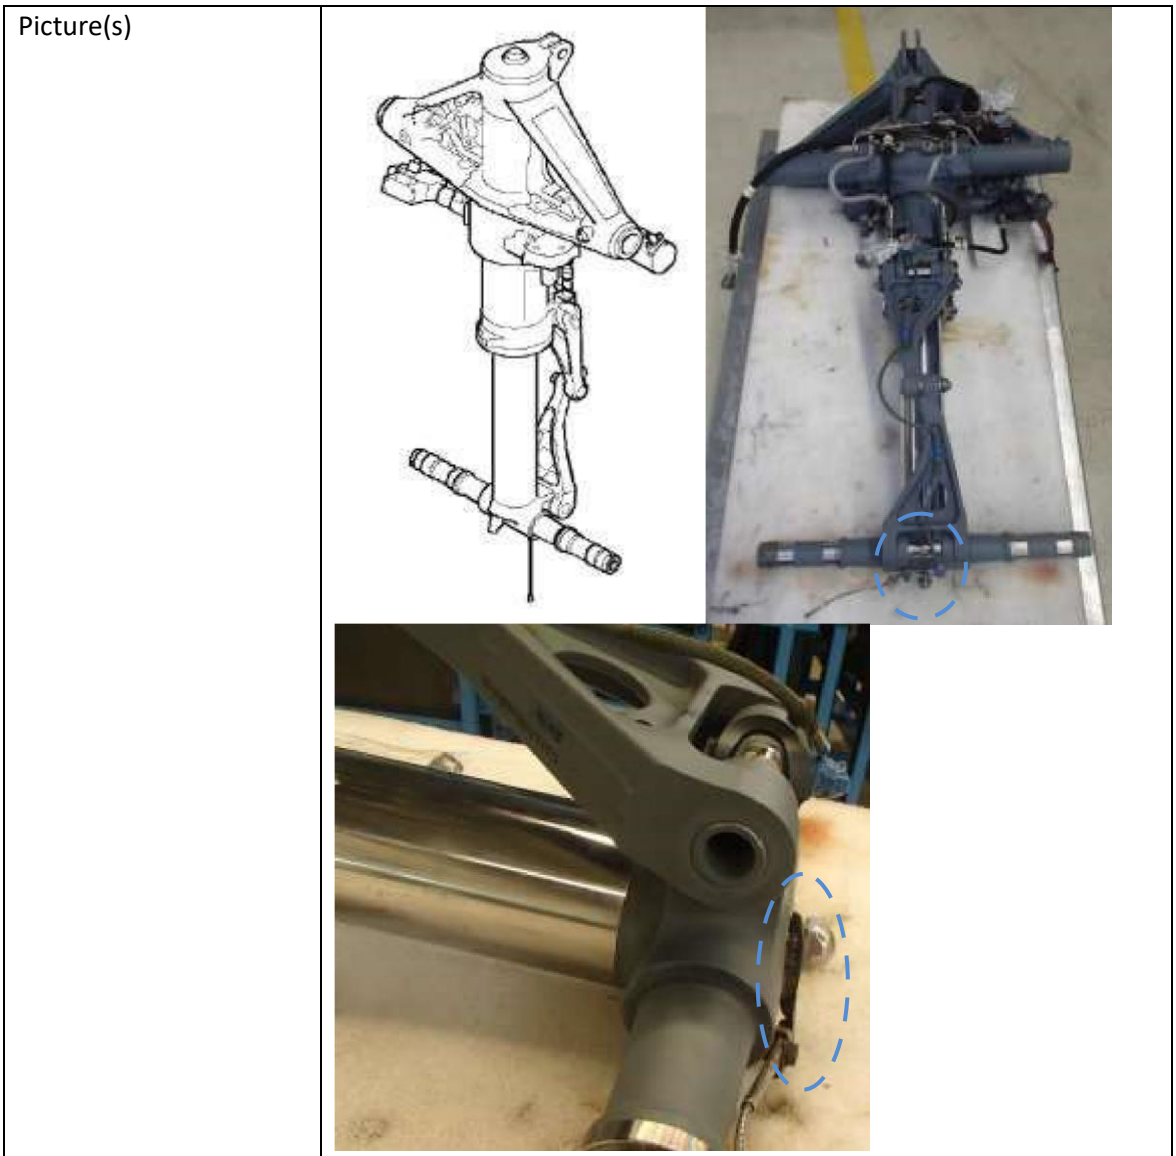
Tail number	N227
ATA nr	32-21
NCage code	S322F1501105:H1632

Corroding component		Nose landing gear (NLG) shockstrut – NFH
Component coupled to		
Preliminary analysis	Failure cause	Corrosion of the aluminium of the shockstrut where the cable for discharge of static electricity is connected. The paint is damaged which allowed corrosion to start. The corrosion may be accelerated by galvanic coupling.
	Corrective and/or preventive measures	Use a flexible sealant to seal the aluminium in order to prevent damage of the paint. Sealing of the bronze bushing is not possible because static electricity must be conducted to the cable.
	SR / SB ?	
	Classification	Insufficient corrosion protection

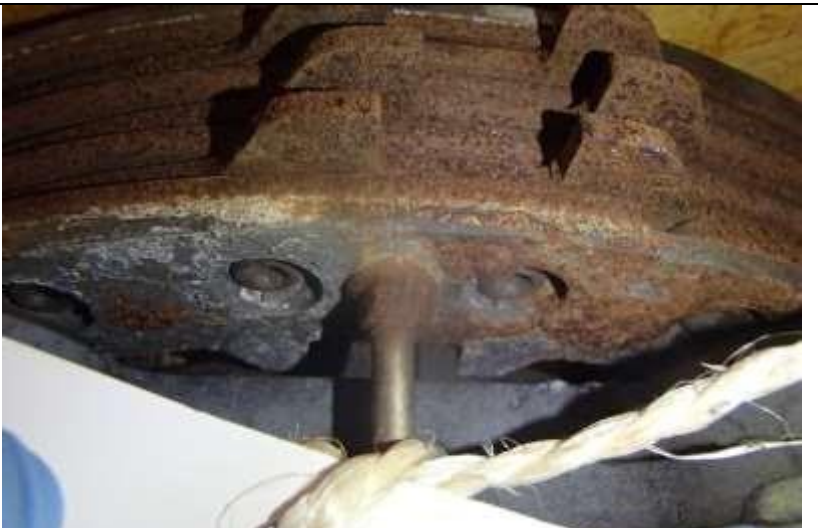
Tail number	N227
ATA nr	32-42
NCage code	S324F2000000:H1632
Picture(s)

Corroding component	Corrosion of brake disks	
Component coupled to		
Preliminary analysis	Failure cause	Salt water environment leads to severe corrosion of steel brake disks.
	Corrective and/or preventive measures	Rinsing of the brake disks may reduce the severity of corrosion. Apply black oxide to the brake disks as protective coating. The black oxide will be removed from the parts that take place in the braking, but the remainder of the brake disks will be protected against corrosion by the coating.
	SR / SB ?	
	Classification	Insufficient corrosion protection

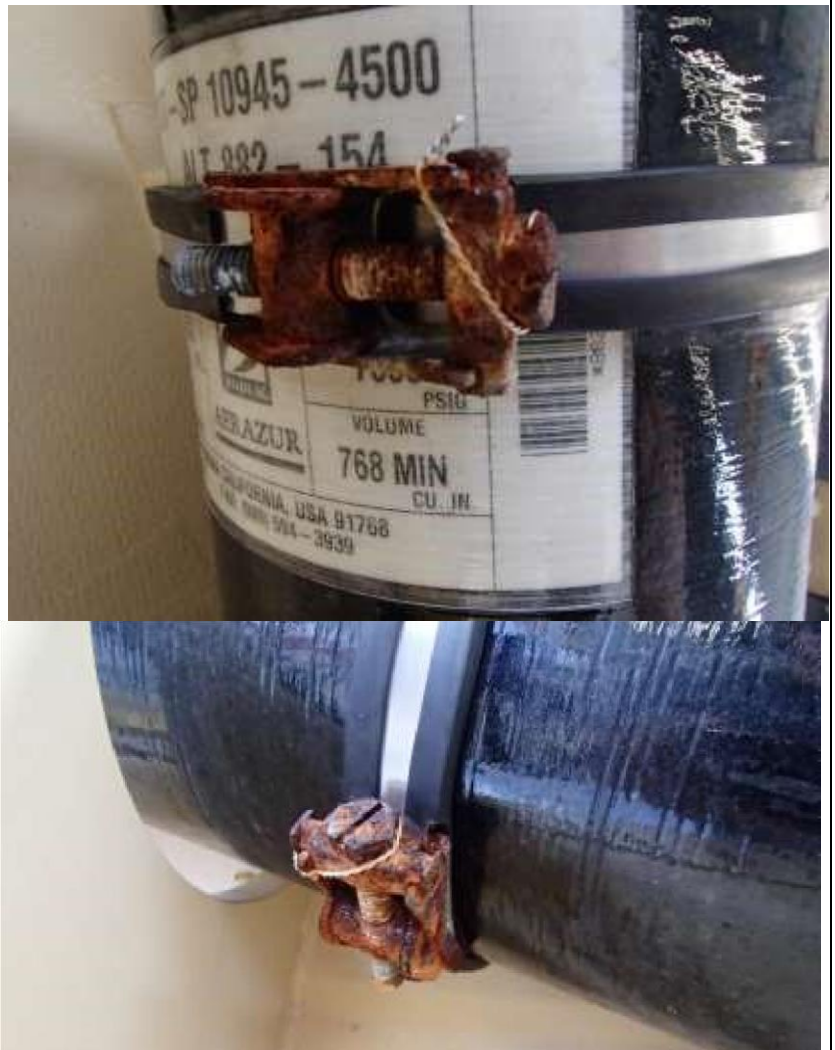
Picture(s)

Corroding component		Floation gear bottle clamps
Component coupled to		Not applicable
Preliminary analysis	Failure cause	Long duration wetness in saline environment caused corrosion of the fasteners on the floation bottles. Only those at the right hand side of the helicopter are affected. Those at the left hand side of the helicopter are in fine condition. The flotation gear is attached to the sponson attachment lug that shows corrosion as well.
	Corrective and/or preventive measures	Replace the clamps. Apply a hard film CPC to the clamps, in addition to the protective coating. Rinse periodically to remove the salt deposited on the clamps.
	SR / SB ?	
	Classification	Wrong design
Tail number		N227
ATA nr		32-91
